# Thoreau Home Inspection

## CONFIDENTIAL INSPECTION REPORT

777 Bliss St, Anywhere, Arizona

6/4/2015 9:00 am to 12:00 pm

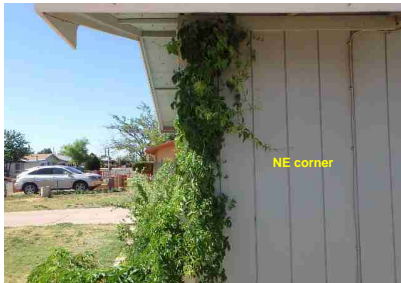
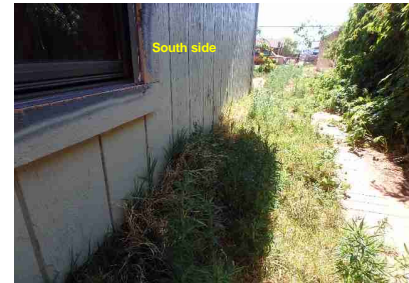
1.3 - Vegetation is encroaching on the structure, and should be kept a minimum of twelve inches away for the general welfare of the walls and foundation.

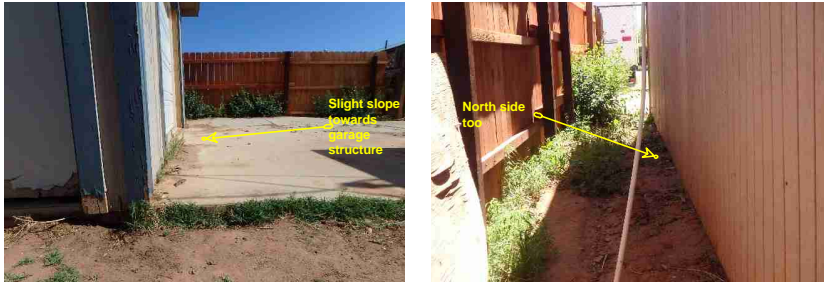
1.10 - There are areas where water will be directed toward the garage instead of away from it and we recommend adding gutters, downspouts and leaders on the north and south sides to direct the roof run-off away from the structure. The grading here is not ideal, for it allows for the possibility of moisture intrusion and/or differential settling and you may wish to have a grading and drainage specialist further evaluate.

There are areas where water is directed toward the house instead of away from it - *Continued*

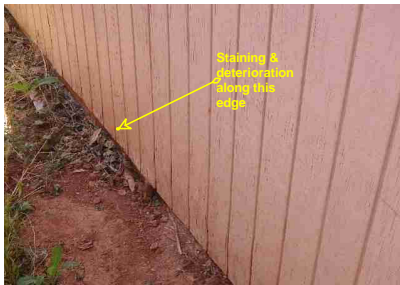
1.12 - Water stains on the walls of the garage indicate uncontrolled run-off, which will eventually deteriorate the finish and require increased maintenance. Therefore, we recommend you seek a second opinion, or have this condition corrected by improving the drainage system.

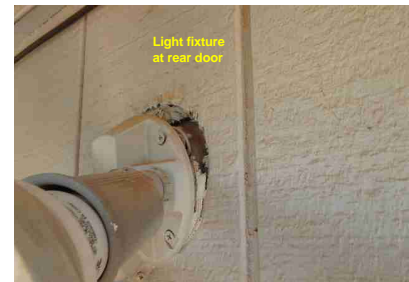
1.13 - There are holes in the siding that we recommend be sealed to prevent pest intrusion.

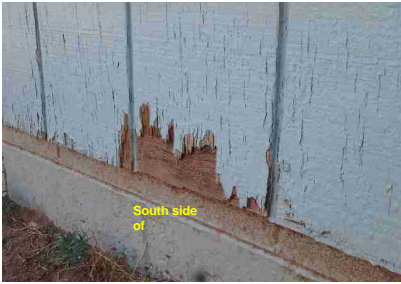
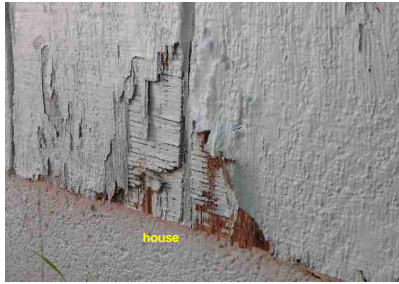
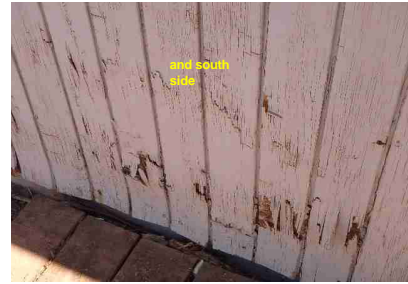
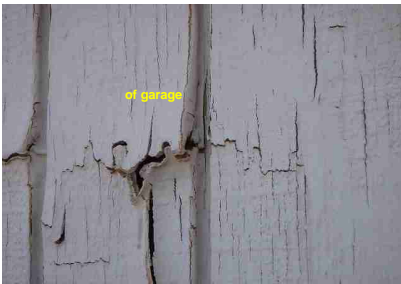
1.14 - Portions of the wood siding are swelling and delaminating as a result of moisture damage and we recommend it be replaced.

Portions of the wood siding are swelling and delaminating as a result of moisture damage - *Continued*

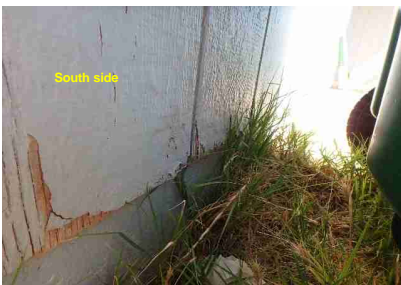
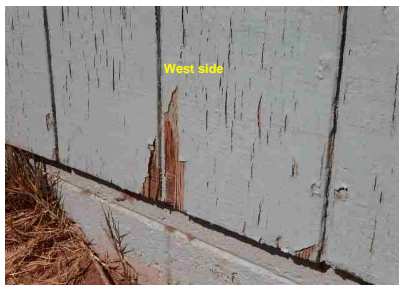
1.16 - Sections of the siding have peeling paint that we recommend be serviced to prevent moisture damage.

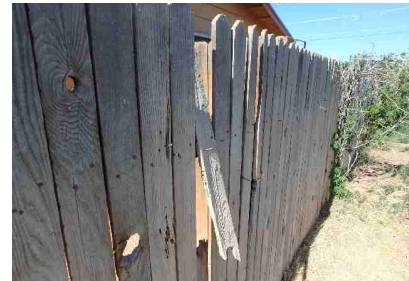
1.21 - Sections of the fence have loose, missing or broken boards that we recommend be repaired

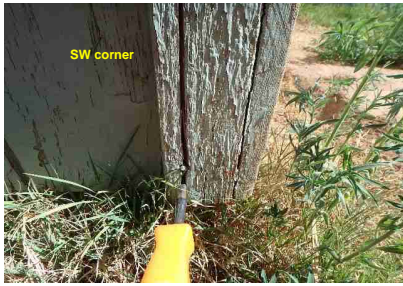
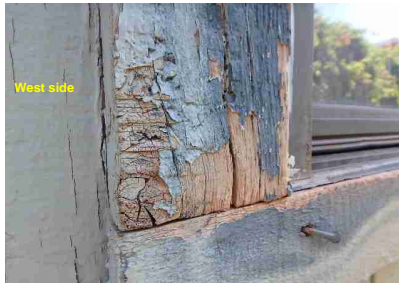
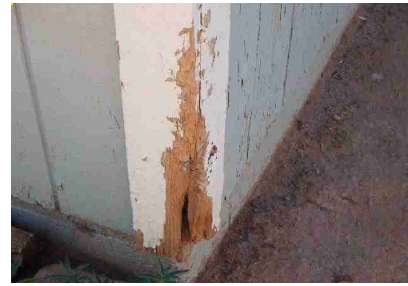
1.22 - There are sections of the fascia and trim that are loose and deteriorated we recommend they be replaced.

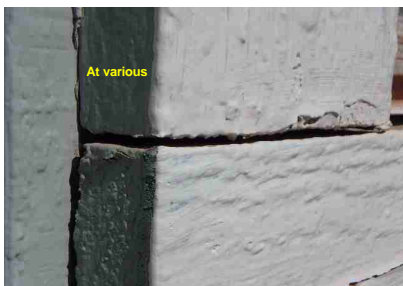
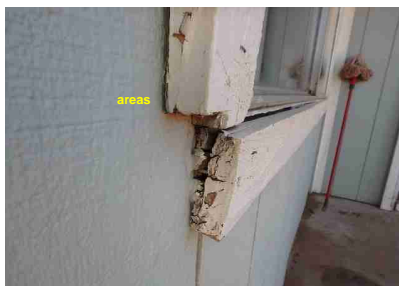
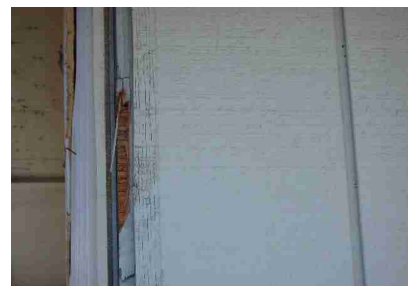
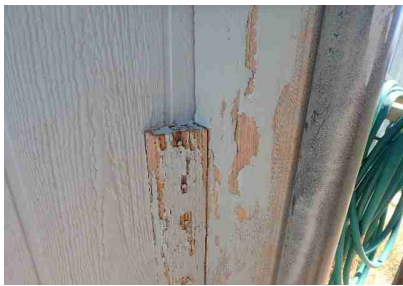
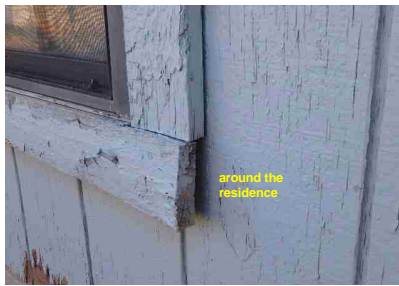
1.23 - The fascia and trim need typical maintenance service such as securing, scraping, sanding, sealing and painting to prevent moisture damage.

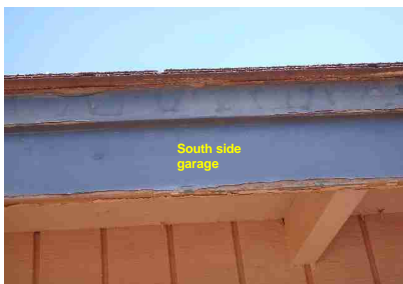
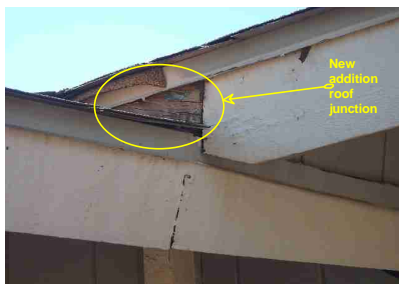
1.24 - Portions of the trim have peeling paint and we recommend it be serviced to prevent deterioration from the sun and moisture.

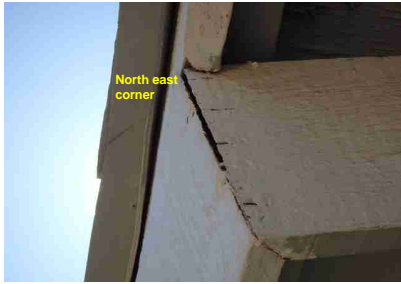
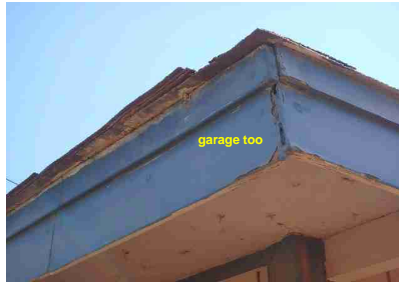
1.25 - The fascia boards are separating at the corners and we recommend these areas be sealed to prevent moisture damage.

The fascia boards are separating at the corners and we recommend these areas be sealed to prevent moisture damage -

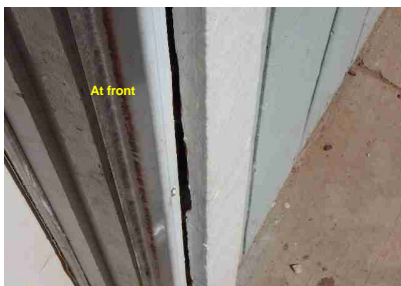
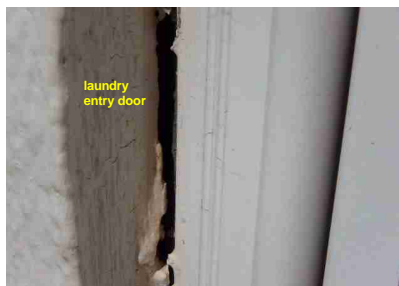
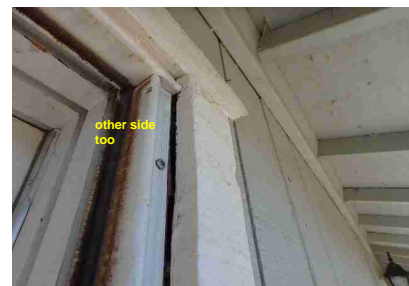
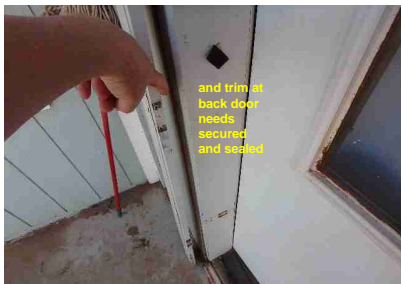
1.26 - There are gaps between the trim and the window or door frames that we recommend be sealed to prevent moisture intrusion.

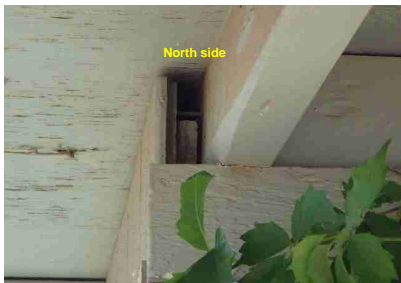
1.27 - Sections of the eaves are open to attic space and we recommend these areas be sealed to prevent pest intrusion.

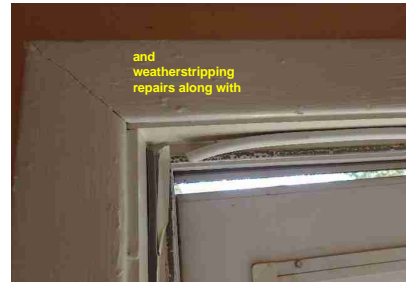
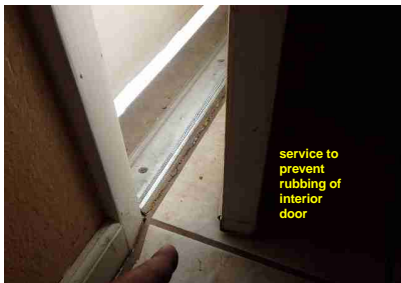
1.29 - The entry doors need maintenance or replacement service of the door trim, hardware and weather stripping.

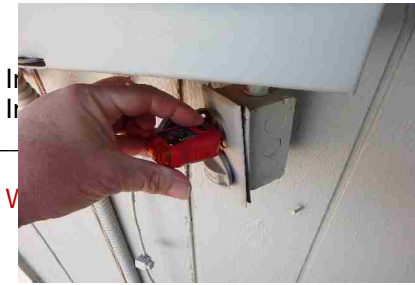
1.34 - We recommend that all of the exterior outlets be upgraded to have ground fault protection.

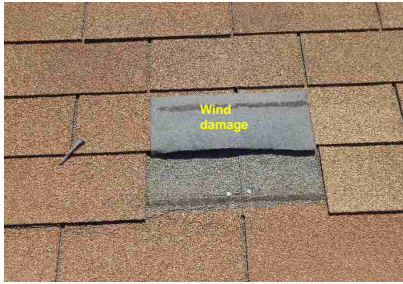
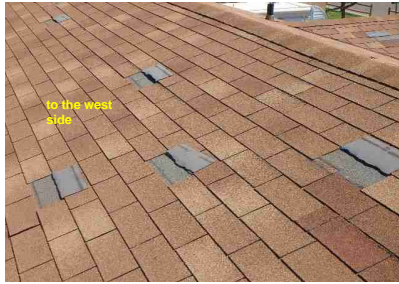
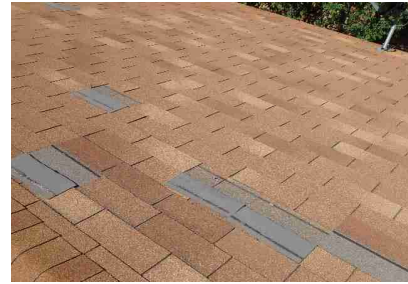
3.4 - There are cracked or missing shingles that we recommend be replaced to prevent exposure and deterioration of the moisture barrier.

There are cracked or missing shingles that we recommend be replaced to prevent exposure and deterioration - *Continuec*

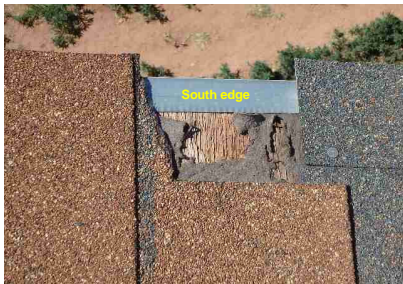
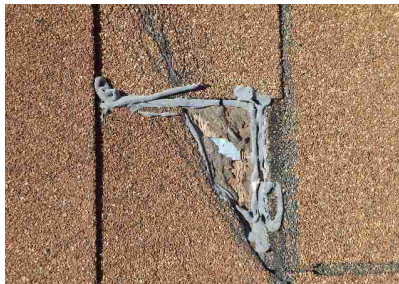
3.5 - Portions of the roof have exposed sheathing and we recommend immediate repairs.

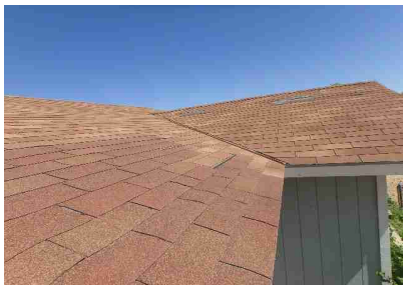
3.7 - There is an area of previous repair that we recommend you monitor.

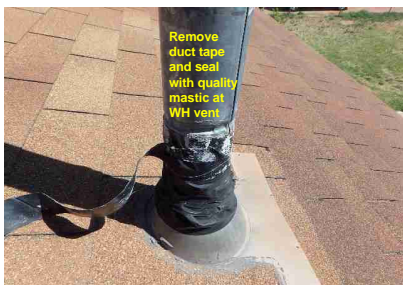
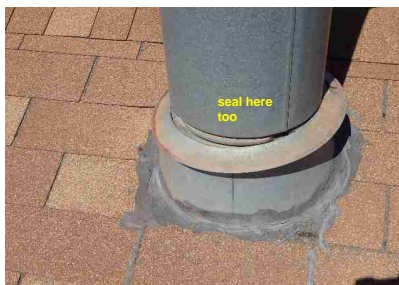
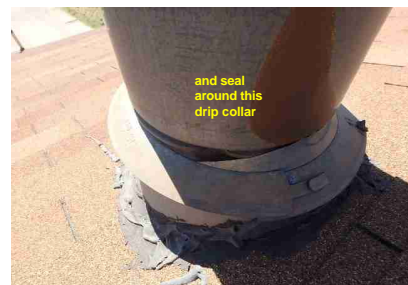
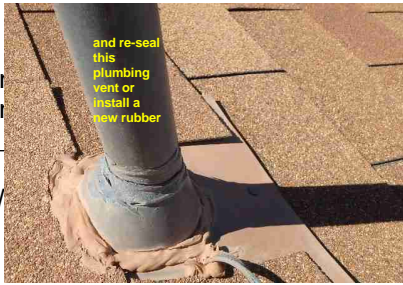
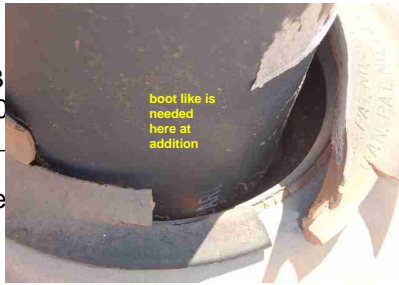
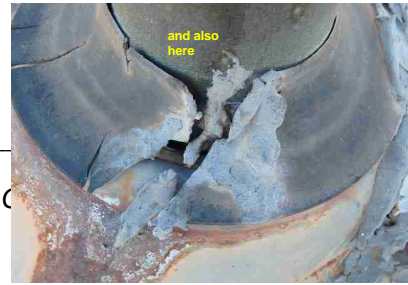
3.8 - We recommend the roof flashings be sealed and regularly maintained. They are comprised of metal that seals valleys and vents and other roof penetrations, and are the most common point of leaks.

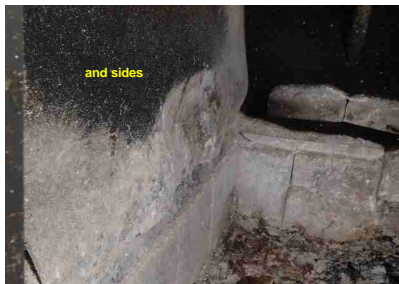
4.5 - The wood stove has buckled and warped due to over heating and we recommend it be further evaluated by a home heating specialist.

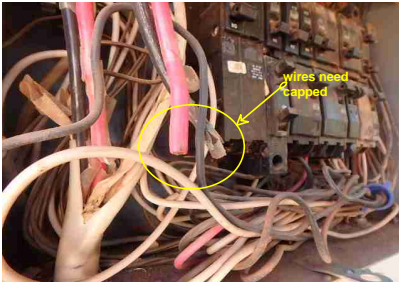
6.5 - There are exposed wires that we recommend be capped.

There are exposed wires that we recommend be capped - *Continued*

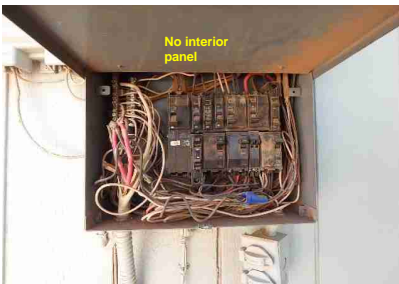
6.8 - The interior panel cover is missing, and we recommend it be replaced.

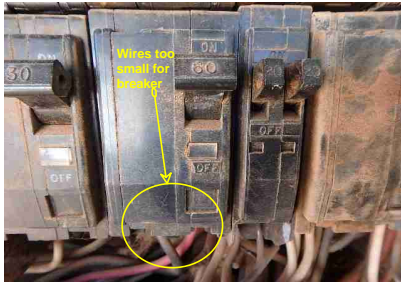
6.11 - A sixty-amp breaker is serving undersized wires, which is a fire-hazard that we recommend be corrected by an electrician.

A twenty-amp breaker is serving undersized wires and we recommend be serviced - *Continued*

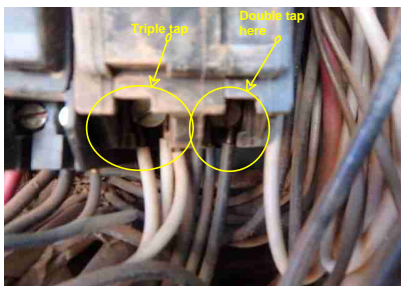
6.12 - A breaker is serving three circuits, which could overload the breaker or create a weak connection. We recommend this condition be evaluated by an electrician.

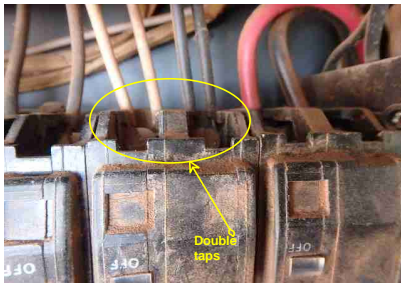
6.13 - Two breakers are each serving two circuits. This is commonly referred to as "double taps" and is inconsistent with generally accepted building practices. We recommend it be evaluated by a qualified electrician.

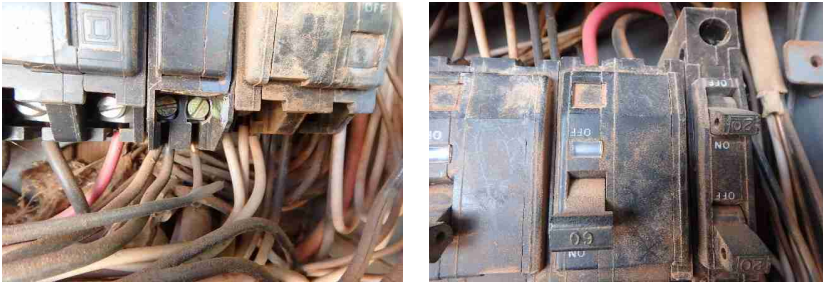
6.14 - There are white wires connected to breakers. Usually, this is indicative of improper wiring and it is safe practice to designate these wires with black or red tape at the breaker and the circuit end point to indicate the wire is hot and we recommend further review and correction by an electrician.

There are white wires connected to breakers - *Continued*

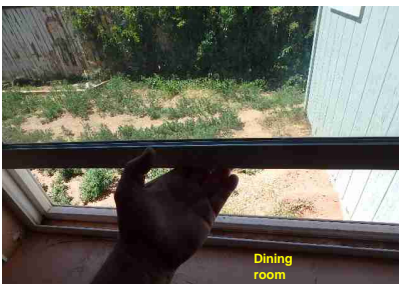
9.7 - A window does not stay open and we recommend return spring service.

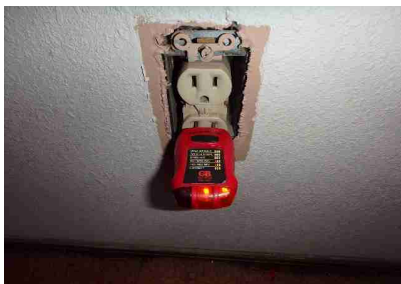
9.12 - Several outlets are missing their covers and we recommend they be replaced.

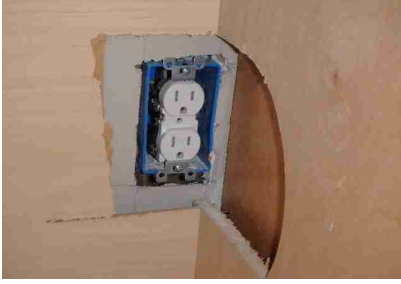
10.15 - An outlet under the sink is missing a cover plate and we recommend it be serviced.

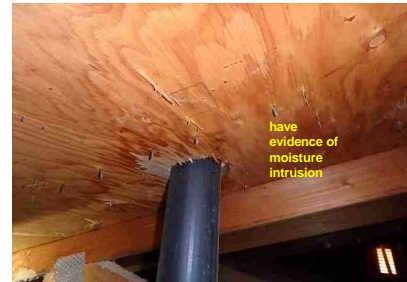
13.4 - Moisture has entered the attic space from defective plumbing vent boots and we recommend they be replaced.

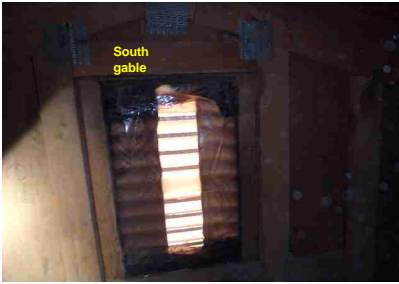
13.5 - Ventilation ports have been sealed or covered with plastic, which we recommend be removed because it defeats the purpose of the vents.

Ventilation ports have been sealed or covered with plastic which we recommend be removed - *Continued*

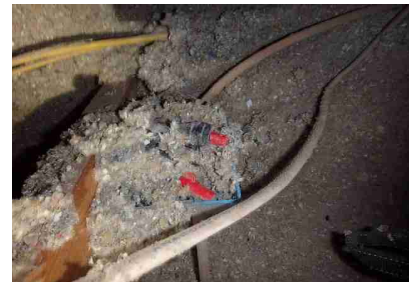
13.6 - There are open electrical junction boxes, which we recommend be sealed to contain any arcing or sparking that might occur.

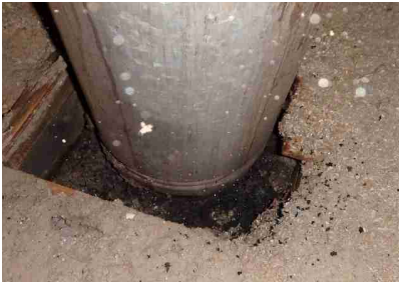
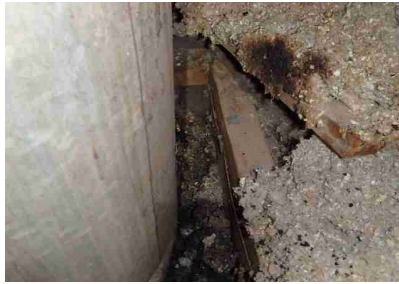
13.9 - The heat vent for the wood stove has charred insulation and wood against the pipe and we recommend they be moved 3 inches away for fire safety.

The heat vent for the wood stove has charred insulation and wood against the pipe and we recommend - *Continued*

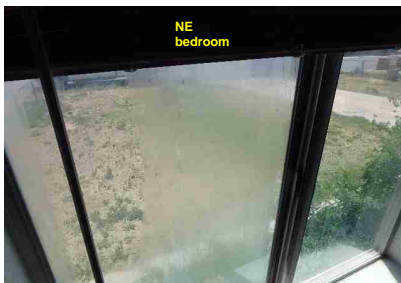
14.5 - A window has a broken hermetic seal, and we recommend it be replaced. This is evident from fogging, or condensation forming between the panes of glass, that confirms that the seal has failed.

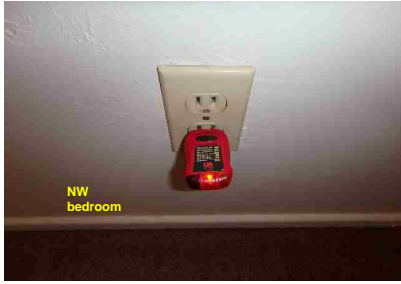
14.9 - We recommend the obsolete and ungrounded outlets need to be replaced modern and safer ones, which provide a pathway for the electrical current to travel harmlessly to ground.

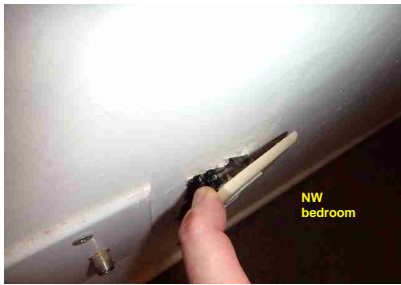
14.10 - An outlet is loose and needs to be re-secured to the wall.

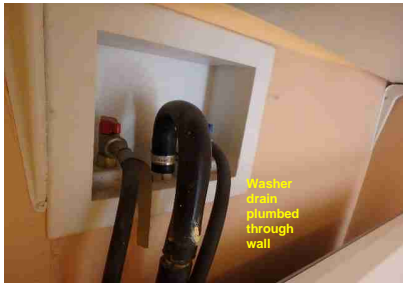
16.8 - The drain pipe from the washer is plumbed to the sink and needs to be further evaluated with correction as necessary by a plumbing specialist.

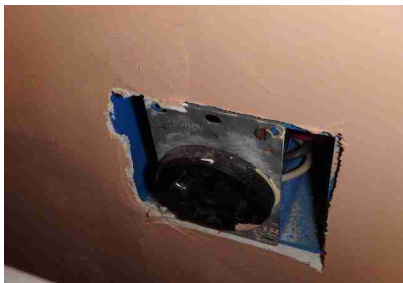
16.10 - The 220 volt receptacle is missing its cover and needs to be replaced.

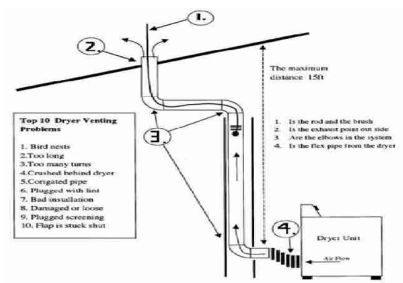
16.11 - Faulty dryer vents have been responsible for thousands of fires, hundreds of injuries, and even deaths. The best vents are a smooth-walled metal type that travels a short distance; all other types should be regarded as suspect, and need to be inspected and/or cleaned bi-annually to ensure that they do not contain trapped lint or moisture.

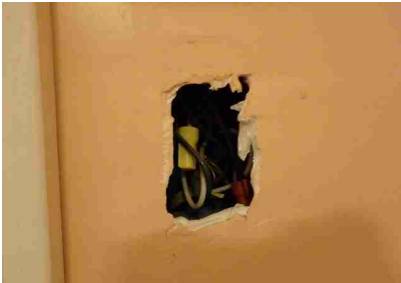
16.15 - There are exposed wires that need to be sealed within a junction box.

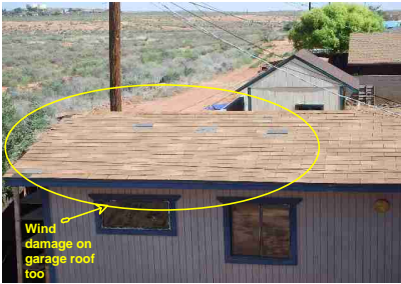
17.10 - The roof has areas where shingles are loose or missing and we recommend they be replaced.
