Thoreau Home Inspection

CONFIDENTIAL INSPECTION REPORT

777 Bliss St, Anywhere, Arizona

6/4/2015 9:00 am to 12:00 pm

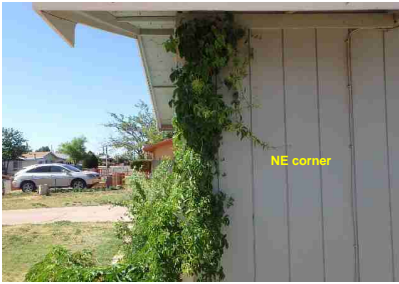
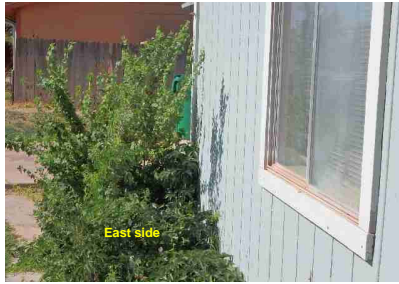
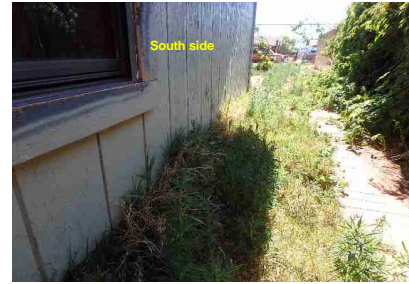
- 1.1 - Vegetation is encroaching on the structure, and should be kept a minimum of twelve inches away for the general welfare of the walls and foundation.

Vegetation is encroaching on the structure and should be kept a minimum of twelve inches away - *Continued*

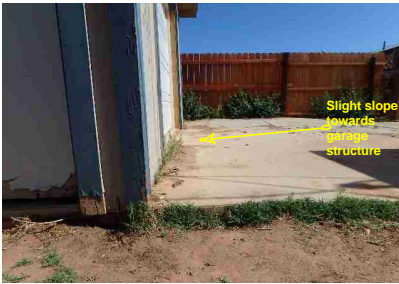
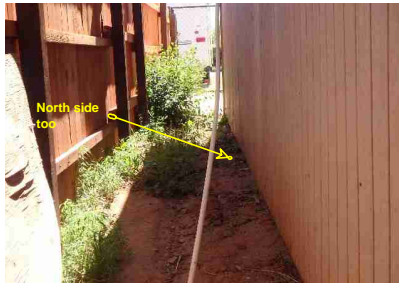
1.3 - There are areas where water will be directed toward the garage instead of away from it and we recommend adding gutters, downspouts and leaders on the north and south sides to direct the roof run-off away from the structure. The grading here is not ideal, for it allows for the possibility of moisture intrusion and/or differential settling and you may wish to have a grading and drainage specialist further evaluate.

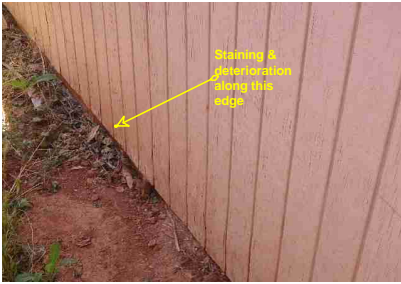
1.4 - Water stains on the walls of the garage indicate uncontrolled run-off, which will eventually deteriorate the finish and require increased maintenance. Therefore, we recommend you seek a second opinion, or have this condition corrected by improving the drainage system.

Water stains on the walls of the residence indicate uncontrolled run-off - *Continued*

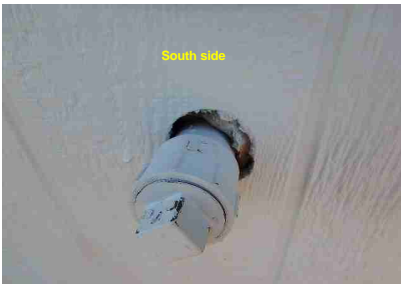
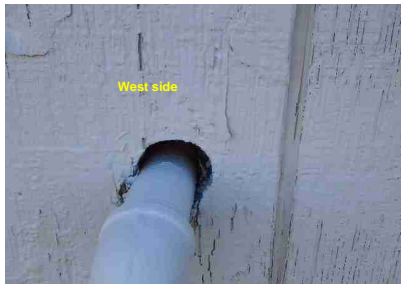
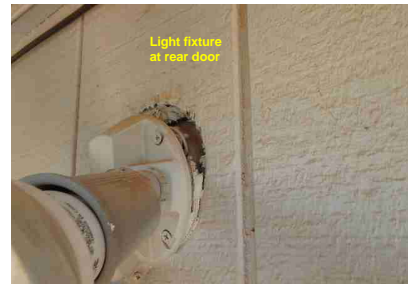
1.5 - There are holes in the siding that we recommend be sealed to prevent pest intrusion.

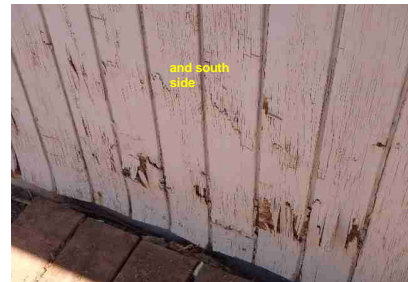
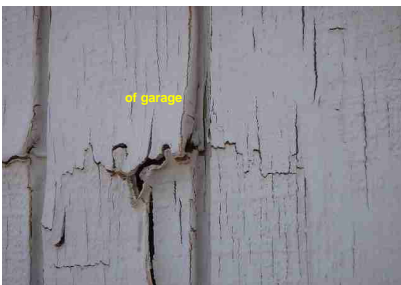
1.6 - Portions of the wood siding are swelling and delaminating as a result of moisture damage and we recommend it be replaced.

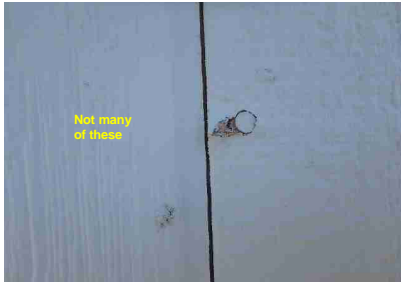
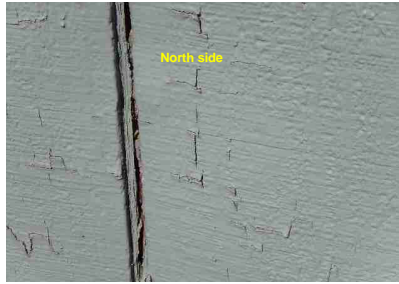
1.7 - There are separations or nail-pops on the siding that we recommend to be sealed to prevent moisture damage.

There are separations or nail-pops on the siding that need to be sealed to prevent moisture damage - *Continued*

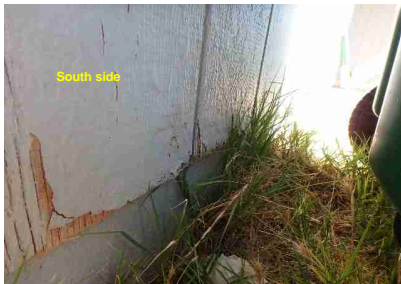
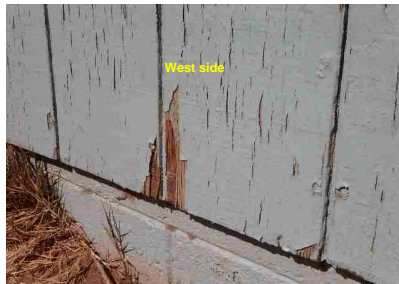
1.8 - Sections of the siding have peeling paint that we recommend be serviced to prevent moisture damage.

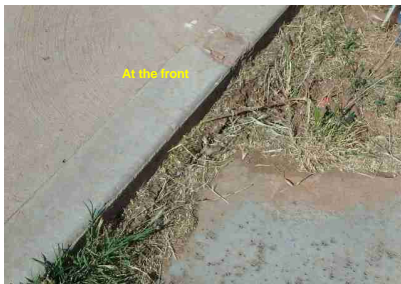
1.9 - There are offsets in the walkways that could prove to be trip-hazards that we recommend be marked and monitored for safety.

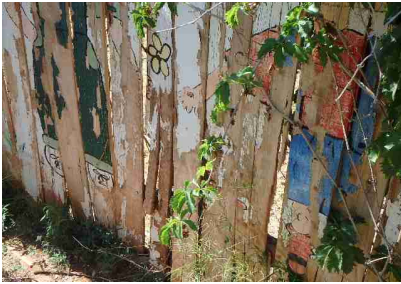
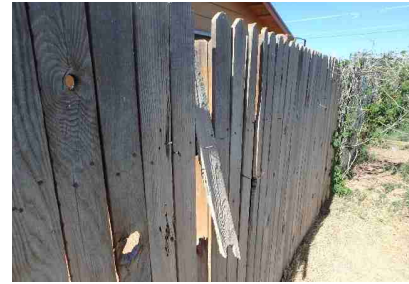
1.10 - Sections of the fence have loose, missing or broken boards that we recommend be repaired

Sections of the fence have loose missing or broken boards that we recommend be repaired - *Continued*

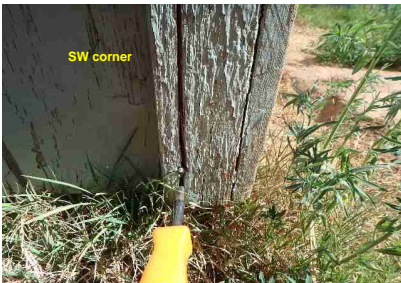
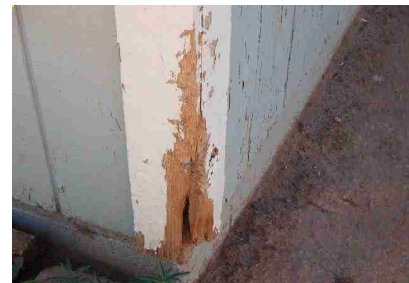
1.11 - There are sections of the fascia and trim that are loose and deteriorated we recommend they be replaced.

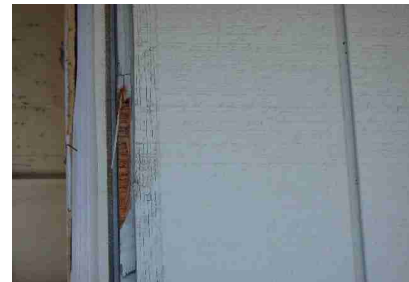
1.12 - The fascia and trim need typical maintenance service such as securing, scraping, sanding, sealing and painting to prevent moisture damage.

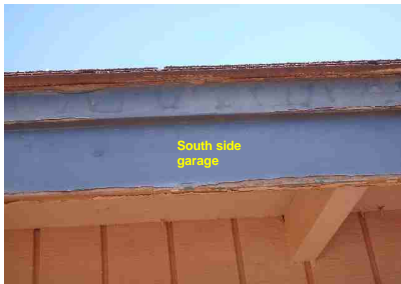
1.13 - Portions of the trim have peeling paint and we recommend it be serviced to prevent deterioration from the sun and moisture.

Portions of the trim have peeling paint and we recommend it be serviced to prevent deterioration from the sun and moisture.

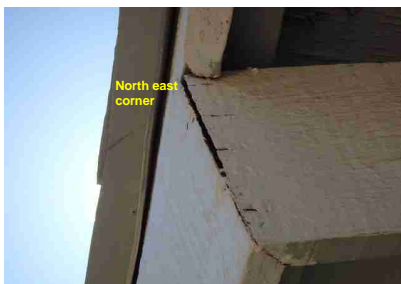
1.14 - The fascia boards are separating at the corners and we recommend these areas be sealed to prevent moisture damage.

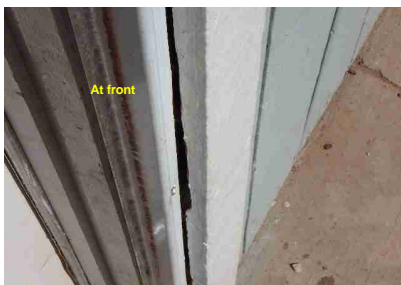
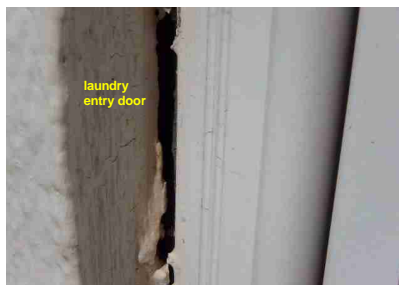
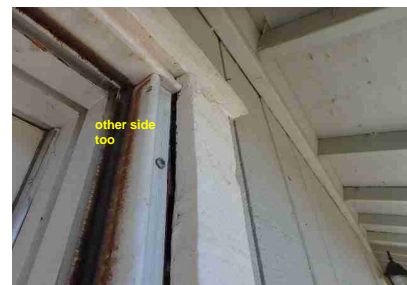
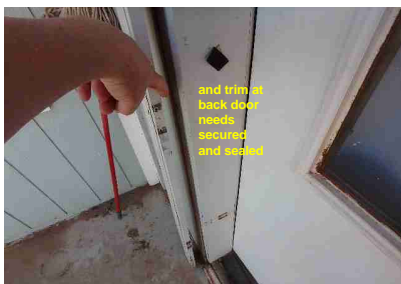
1.15 - There are gaps between the trim and the window or door frames that we recommend be sealed to prevent moisture intrusion.

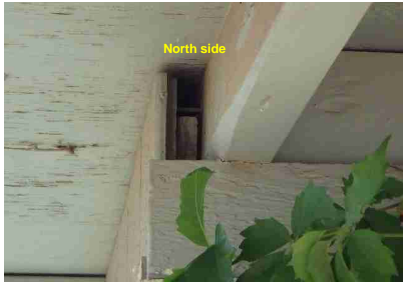
1.16 - Sections of the eaves are open to attic space and we recommend these areas be sealed to prevent pest intrusion.

Sections of the eaves are open to attic space and we recommend these areas be sealed to prevent pest intrusion - *Contir.*

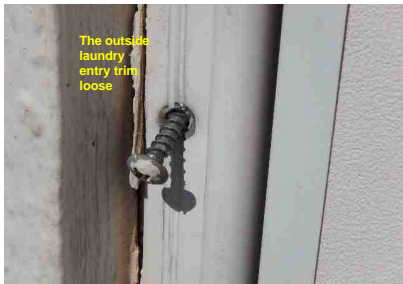
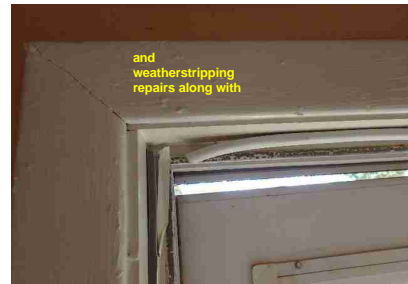
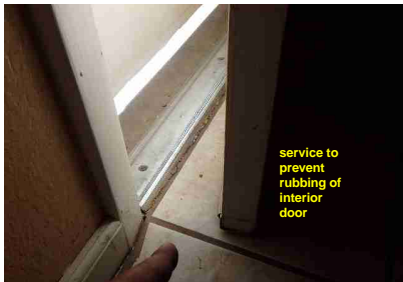
1.18 - The entry doors need maintenance or replacement service of the door trim, hardware and weather stripping.

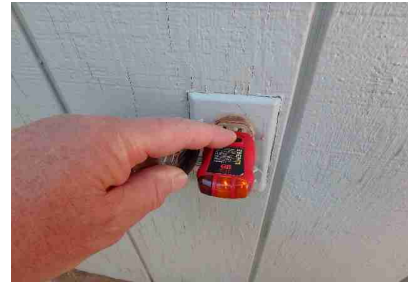
1.20 - We recommend that all of the exterior outlets be upgraded to have ground fault protection.

We recommend that all of the exterior outlets be upgraded to have ground-fault protection - *Continued*

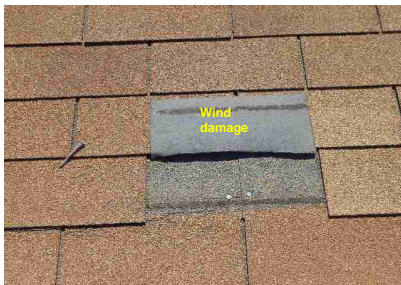
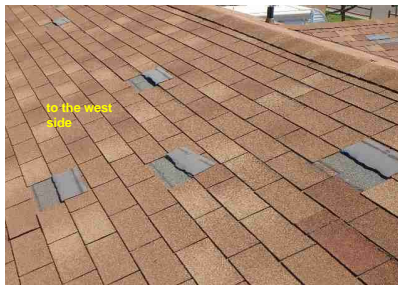
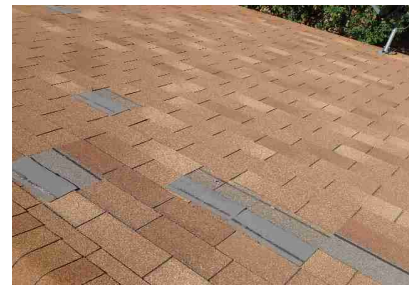
3.2 - There are cracked or missing shingles that we recommend be replaced to prevent exposure and deterioration of the moisture barrier.

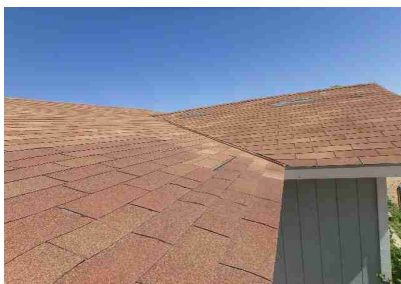
3.5 - There is an area of previous repair that we recommend you monitor.

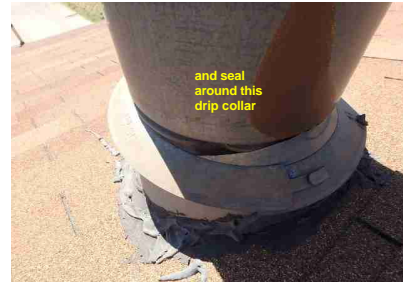
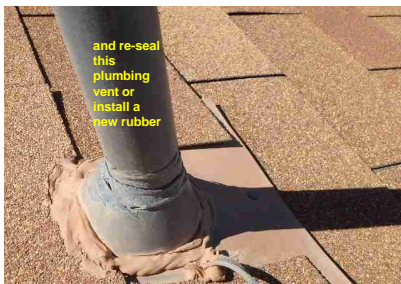
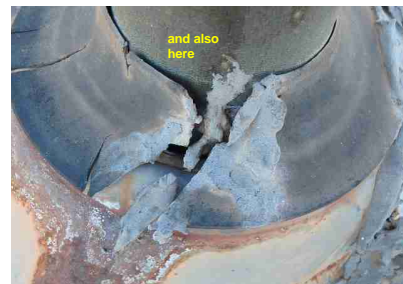
3.6 - We recommend the roof flashings be sealed and regularly maintained. They are comprised of metal that seals valleys and vents and other roof penetrations, and are the most common point of leaks.

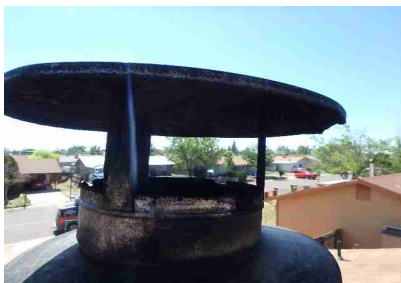
4.1 - The chimney does not have a spark arrestor, which is mandated in most jurisdictions and we recommend one be installed.

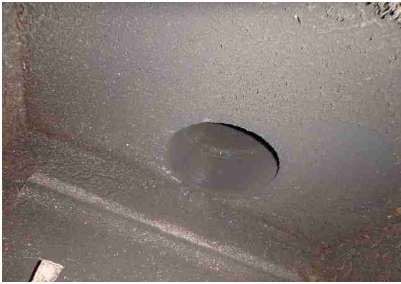
4.3 - The interior heat plate/shield is missing and we recommend it be replaced.

The interior heat plate-shield is missing and we recommend it be replaced - *Continued*

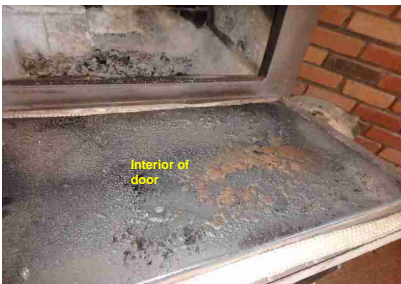
4.4 - The wood stove has buckled and warped due to over heating and we recommend it be further evaluated by a home heating specialist.

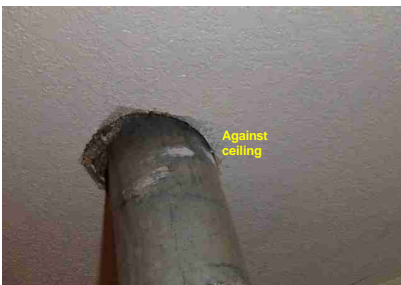
5.1 - The vent pipe is too close to combustible material and we recommend that it be serviced. A single-walled vent pipe should be six inches away from any combustible material, and a double-walled vent pipe should be one inch away.

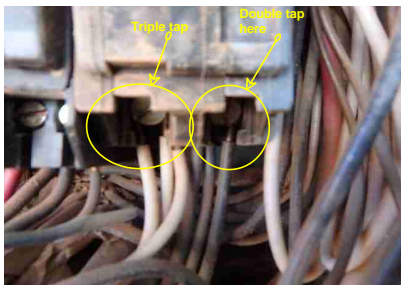
6.7 - A breaker is serving three circuits, which could overload the breaker or create a weak connection. We recommend this condition be evaluated by an electrician.

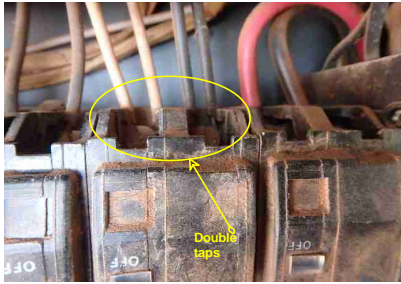
6.8 - Two breakers are each serving two circuits. This is commonly referred to as "double taps" and is inconsistent with generally accepted building practices. We recommend it be evaluated by a qualified electrician.

Two breakers are each serving two circuits referred to as double taps - *Continued*

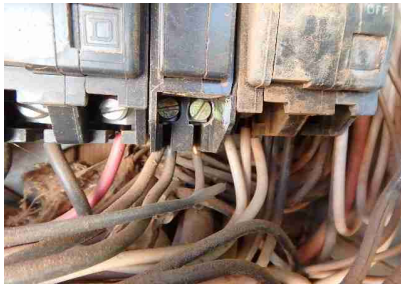
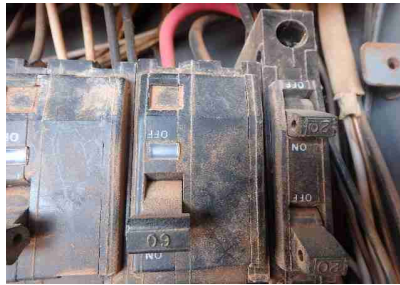
6.9 - There are white wires connected to breakers. Usually, this is indicative of improper wiring and it is safe practice to designate these wires with black or red tape at the breaker and the circuit end point to indicate the wire is hot and we recommend further review and correction by an electrician.

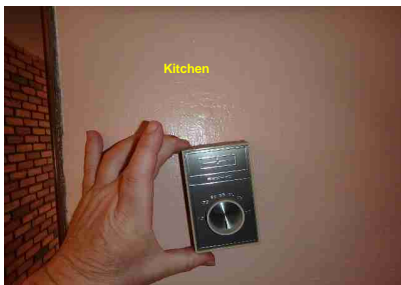
7.1 - A thermostat is loose and we recommend it be secured to the wall.

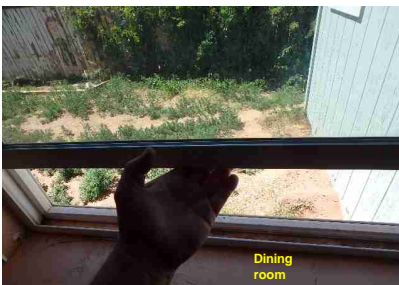
9.4 - A window does not stay open and we recommend return spring service.

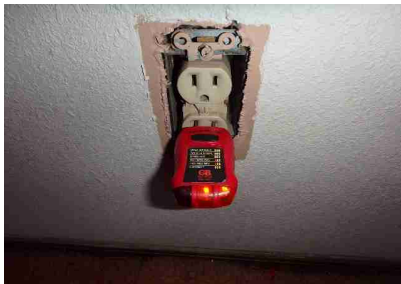
9.6 - Several outlets are missing their covers and we recommend they be replaced.

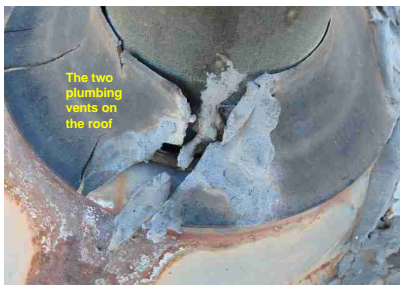
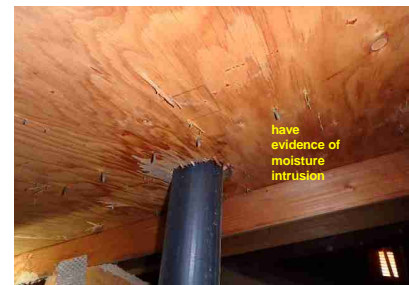
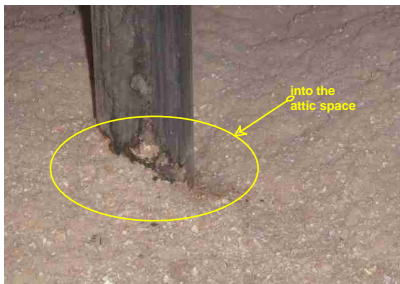
13.1 - Moisture has entered the attic space from defective plumbing vent boots and we recommend they be replaced.

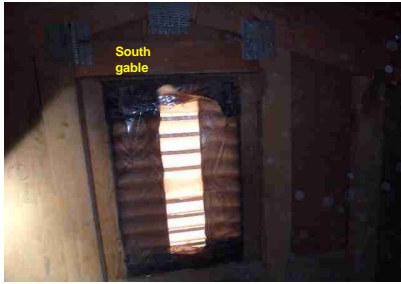
13.2 - Ventilation ports have been sealed or covered with plastic, which we recommend be removed because it defeats the purpose of the vents.

Ventilation ports have been sealed or covered with plastic which we recommend be removed - *Continued*

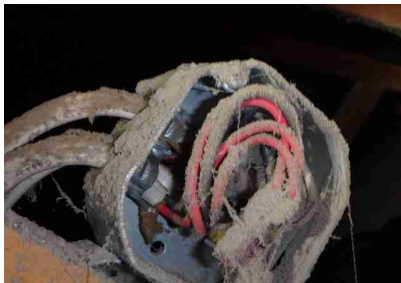
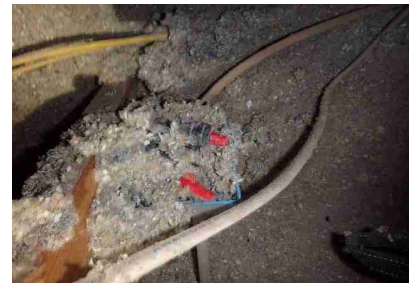
13.3 - There are open electrical junction boxes, which we recommend be sealed to contain any arcing or sparking that might occur.

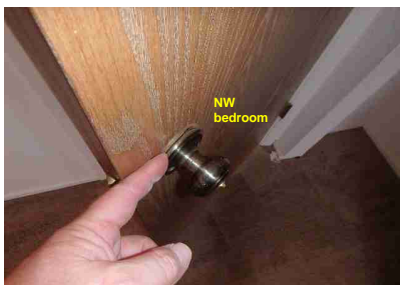
14.1 - A door knob is loose and we recommend it be serviced.

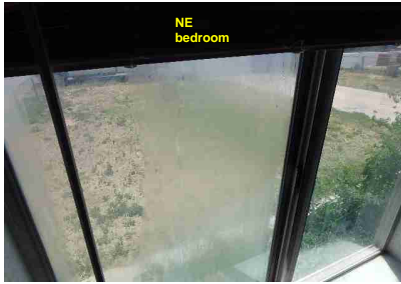
14.2 - A window has a broken hermetic seal, and we recommend it be replaced. This is evident from fogging, or condensation forming between the panes of glass, that confirms that the seal has failed.

A window has a broken hermetic seal and should be replaced - *Continued*

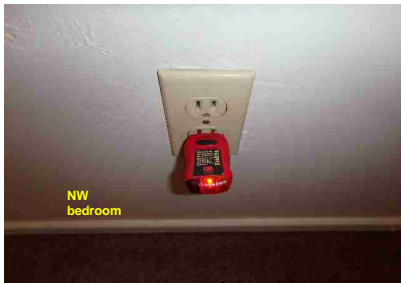
14.3 - We recommend the obsolete and ungrounded outlets need to be replaced modern and safer ones, which provide a pathway for the electrical current to travel harmlessly to ground.

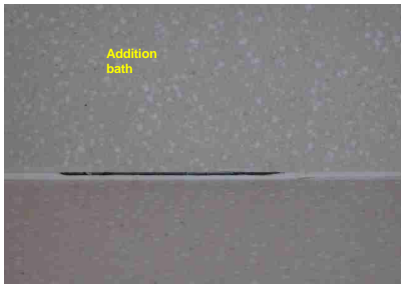
15.1 - There is a separation between the basin and the countertop, which we recommend be sealed to forestall moisture intrusion between the cabinet and the wall.

There is a separation between the basin and the countertop that we recommend be sealed - *Continued*

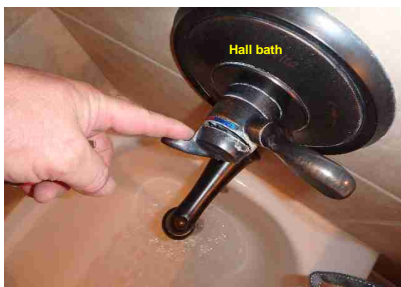
15.2 - The tub/shower valves are loose or missing components, and we recommend they be serviced.

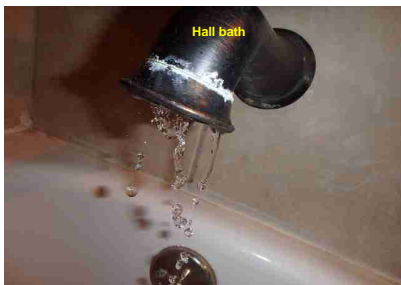
15.3 - The shower diverter valve in the tub/shower is defective, and we recommend it be serviced.

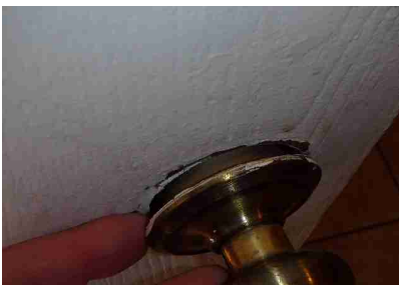
16.1 - The door knob needs to be serviced to work smoothly.

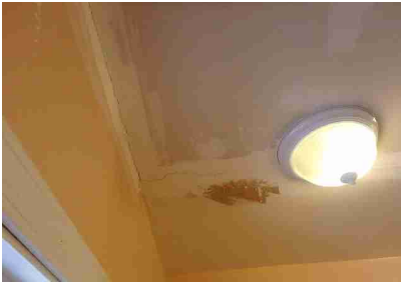
16.2 - There is a repair on the ceiling, which we advise you ask the sellers to explain or have explored further.

There is a moisture stain on ceiling that we advise be explored - *Continued*

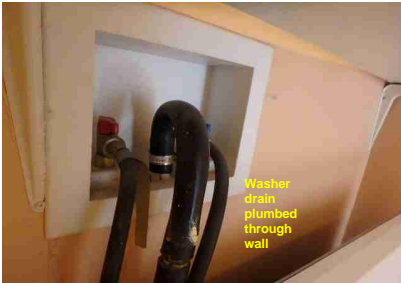
16.3 - The drain pipe from the washer is plumbed to the sink and needs to be further evaluated with correction as necessary by a plumbing specialist.

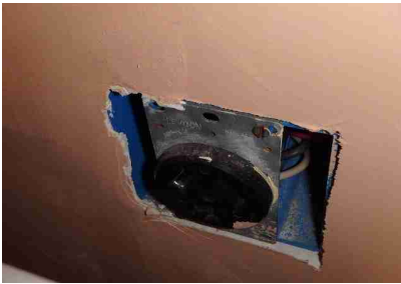
16.4 - The 220 volt receptacle is missing its cover and needs to be replaced.

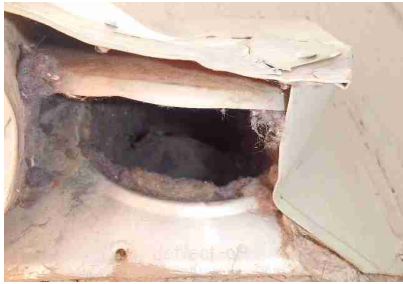
16.5 - The dryer vent cover is bent or crushed restricting its flow and we recommend it be serviced.

The dryer vent cover is bent or crushed restricting its flow and we recommend it be serviced - *Continued*

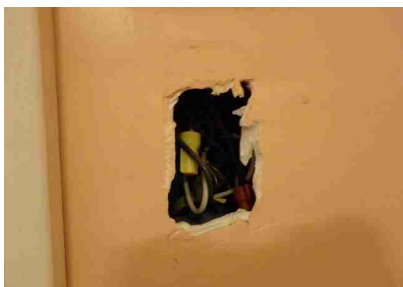
16.6 - There are exposed wires that need to be sealed within a junction box.

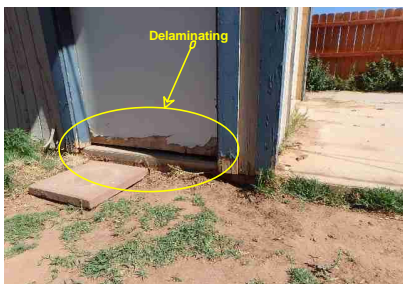
17.1 - The base of the garage side door is moisture damaged and delaminating, and we recommend it be repaired.

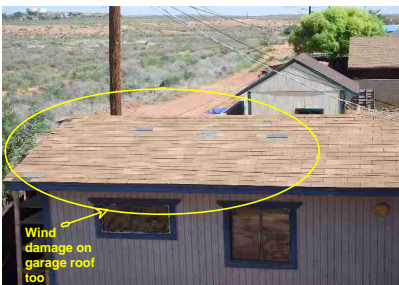
17.6 - The roof has areas where shingles are loose or missing and we recommend they be replaced.
