Inspection Report

Property Address:
1000 W Hazel Way
Flagstaff AZ 86001

General Summary

Address
1000 W Hazel Way
Flagstaff AZ 86001

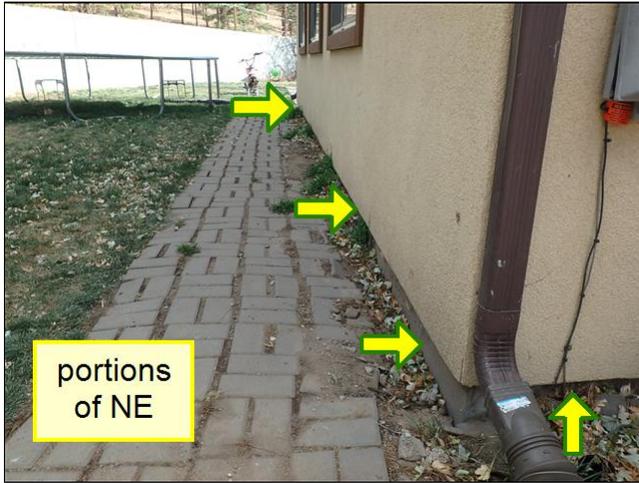
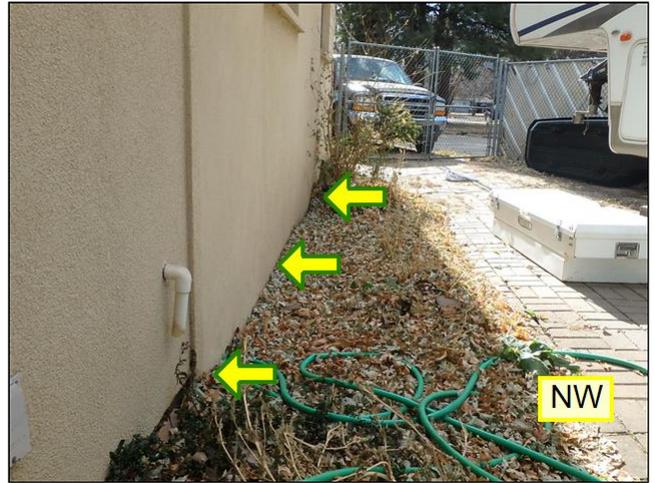
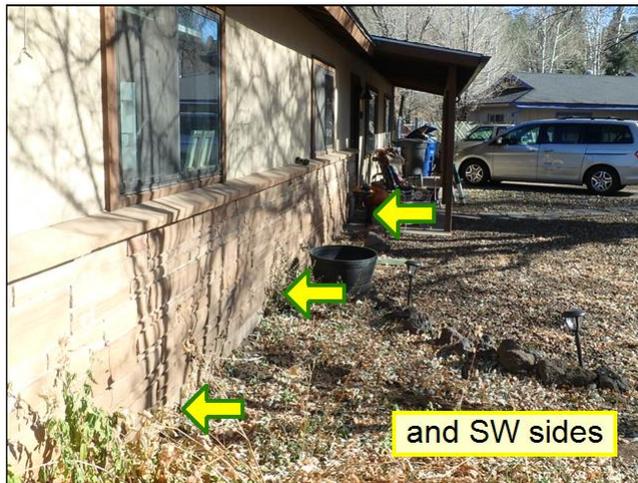
There are areas where water will be directed toward the house instead of away from it. This is not ideal, for it allows for the possibility of moisture intrusion and/or differential settling/heaving and we recommend having the landscaping and drainage at these locations corrected by a qualified person.

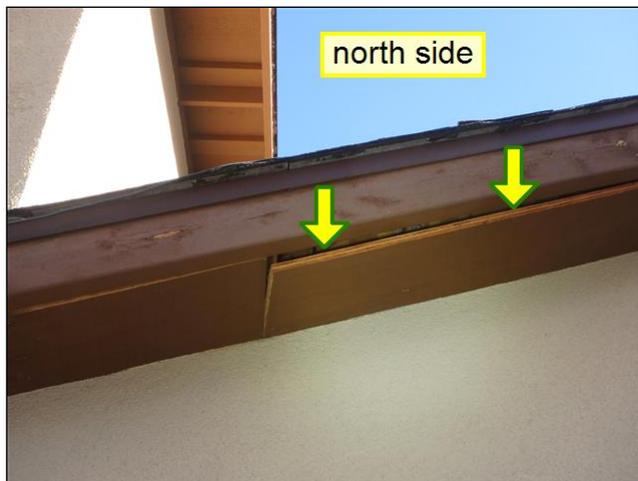
1.3 Item 1(Picture)

The soffit cover/panel is not securely fastened in places. The purpose of the soffit cover (other than cosmetic) is to help prevent pests from entering the attic. Recommend re-securing and sealing soffit panels where needed.

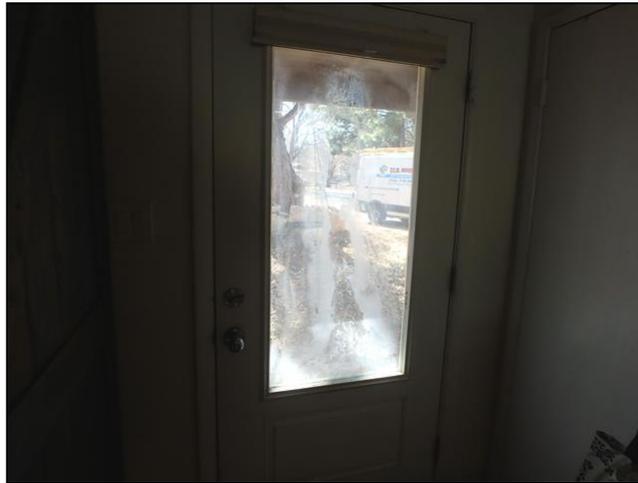
1.4 Item 1(Picture)

The double-glazing in the front entry door window showed symptoms of a breached seal, or failure of the seal between the two pieces of glass. These symptoms often take the form of condensation or silt between the panes of an insulated glass unit. These failures are more a cosmetic consideration than a functional one, as the breach may not appreciably affect the thermal insulation value of the window unit. However, the "fog" or silt cannot be removed by cleaning the exposed surfaces of the unit. Additional info [here](#). Recommend replacement by a qualified technician

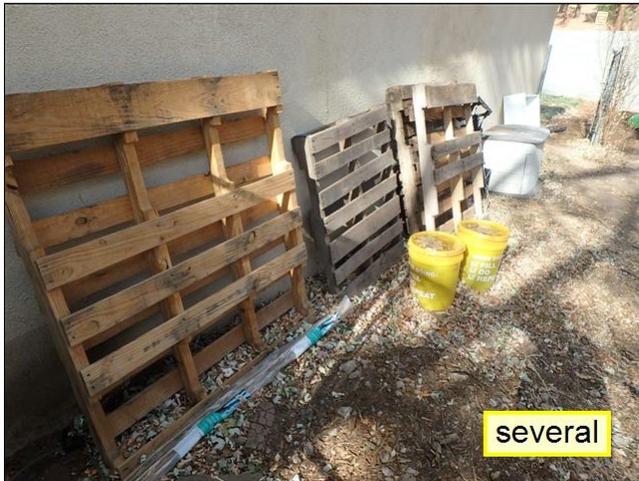
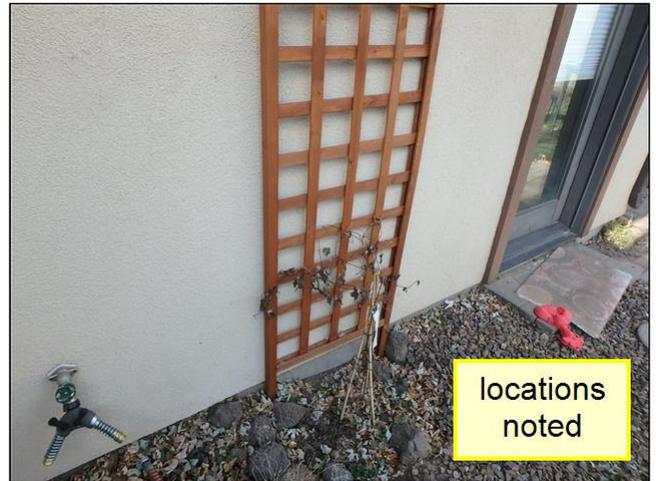
There are areas on the property with wood debris in direct contact with the ground and near the structure. This condition is favorable for wood-destroying organisms and we recommend it be removed.

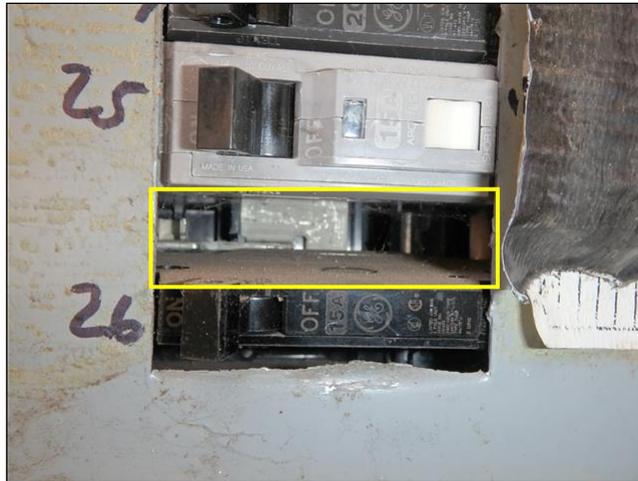
2.2 Item 1(Picture)

There are some empty breaker slots that are exposed at the panel. This is a safety hazard, as a person could get shocked or killed by sticking their finger into the hole. There are panel plugs available at stores that sell electrical supplies. Recommend plugging these holes with the proper sized device.

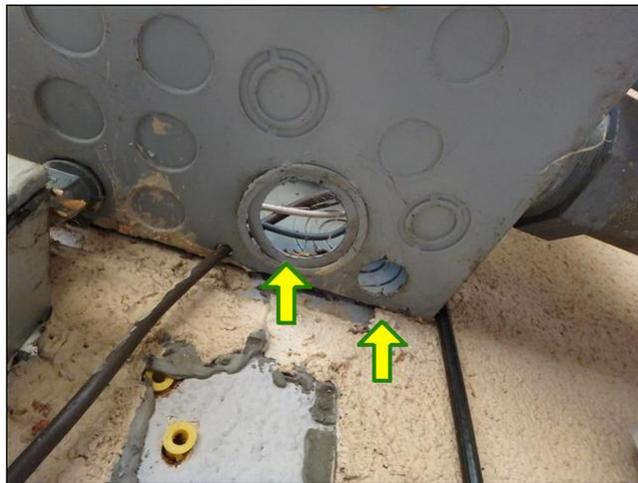
2.2 Item 2(Picture)

There is an open knock out in the panel. This is a safety hazard, as a person could get shocked and or killed by sticking their finger into the hole. This is also an access point for insects or small creatures which can gain entrance through the hole and cause a short or fire. There are panel plugs available at stores that sell electrical supplies and we recommend plugging the hole with the proper device.

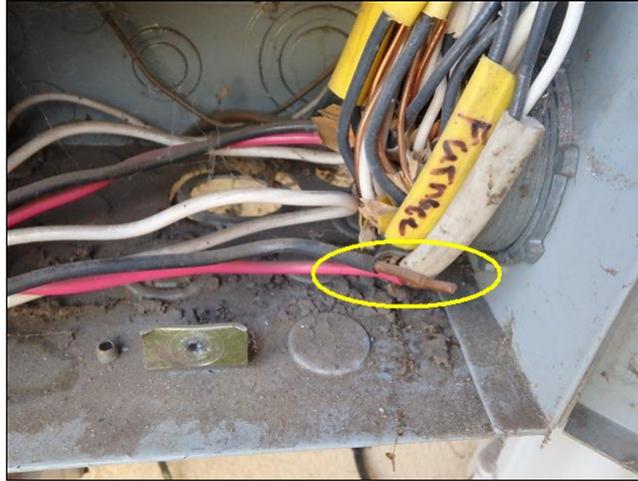
2.3 Item 1(Picture)

There are exposed wires that need to be properly capped.

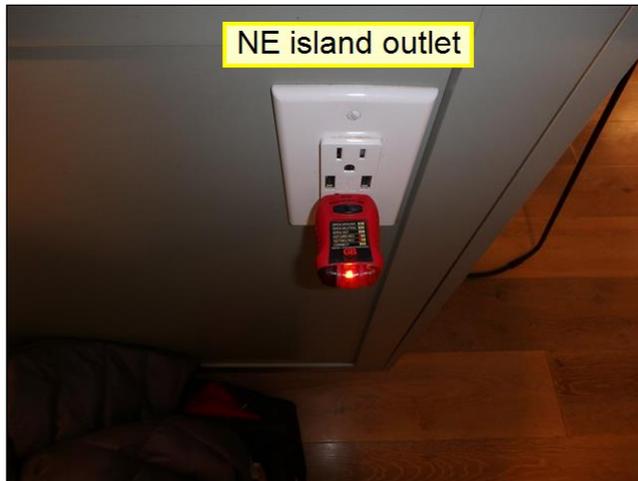
2.5 Item 1(Picture)

An outlet tested with an open ground and we recommend it be serviced by a qualified person.

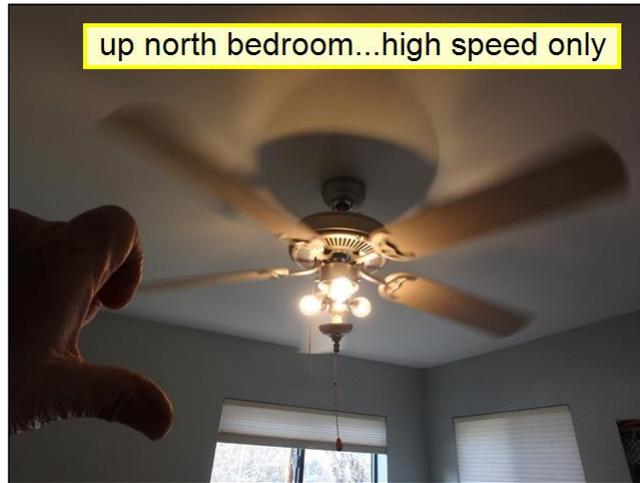
2.5 Item 2(Picture)

A ceiling fan is out of balance and we recommend it be serviced.

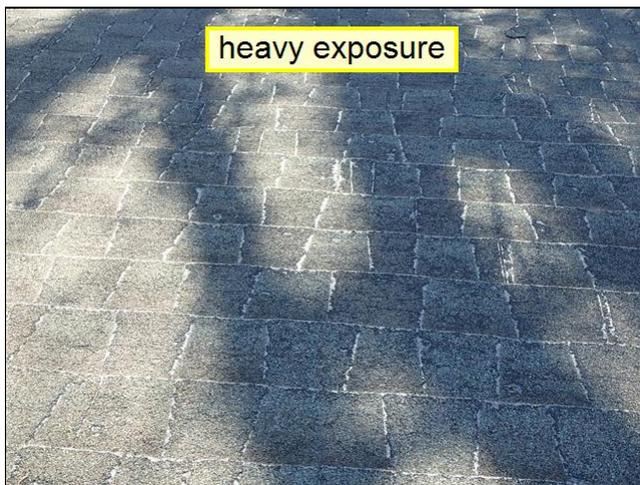
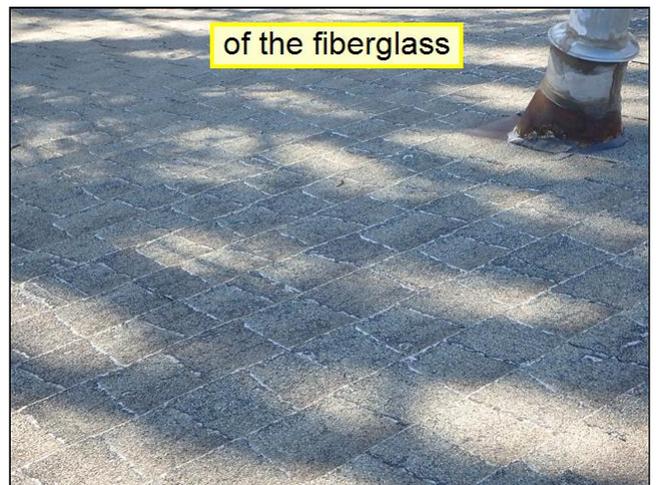
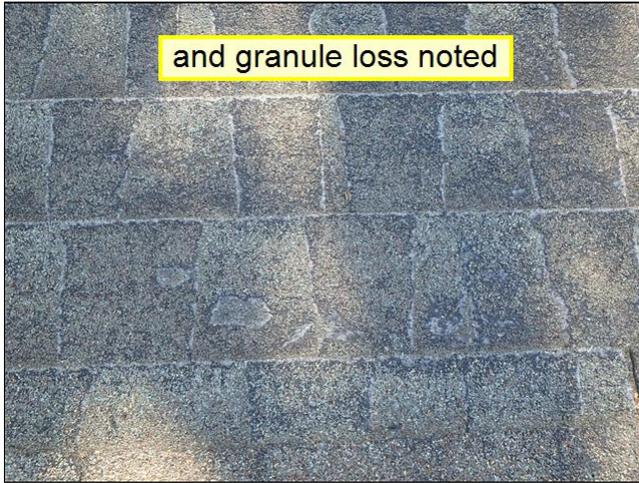
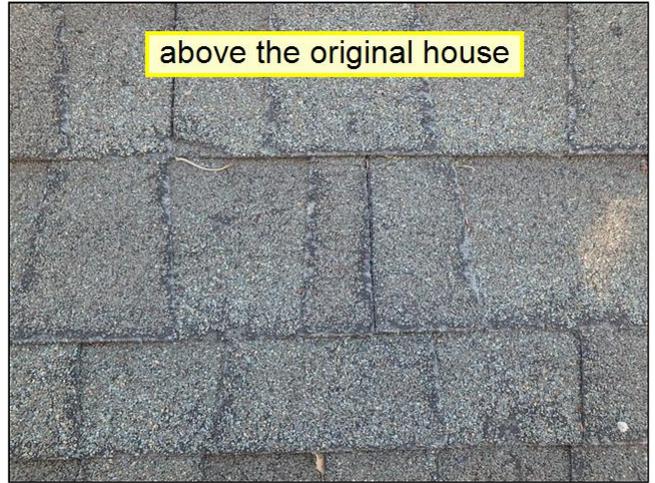
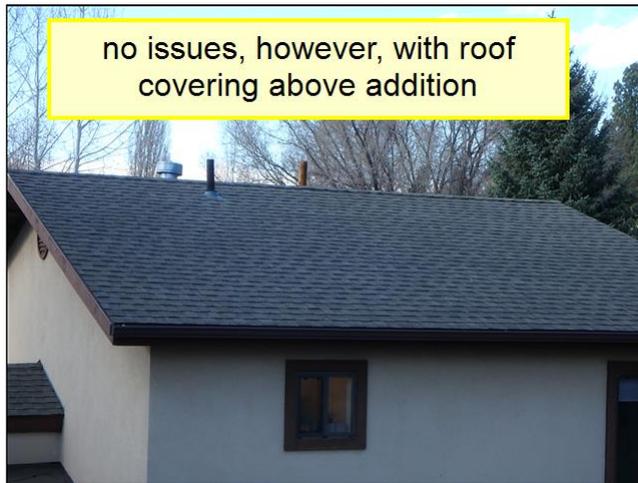
Portions of the roof covering material are in the primary stages of decomposition, which means that the roof is in decline and susceptible to leaks. It will need to be maintained and closely monitored because it is reaching the end of its serviceable life, and we recommend you consult a roofing specialist for a second opinion and discuss your options.

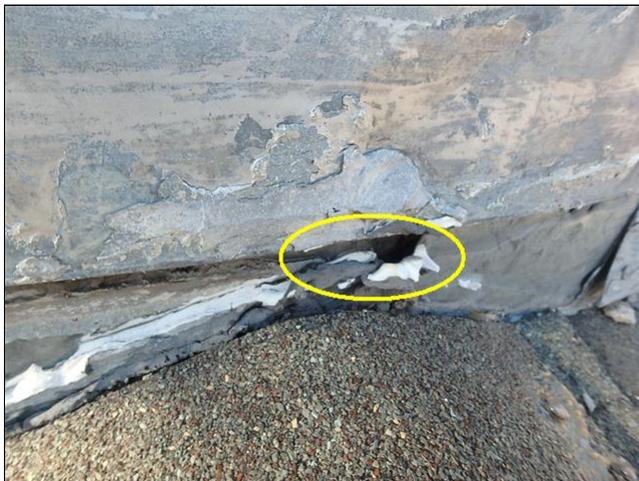
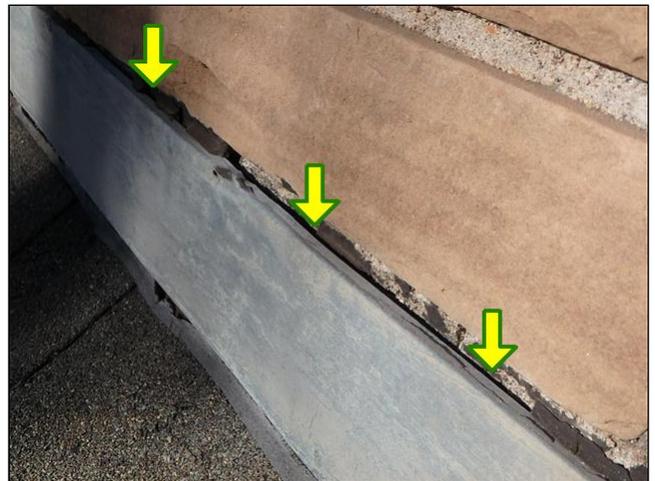
The metal chimney flashing needs sealed to prevent moisture intrusion into the attic and living space.

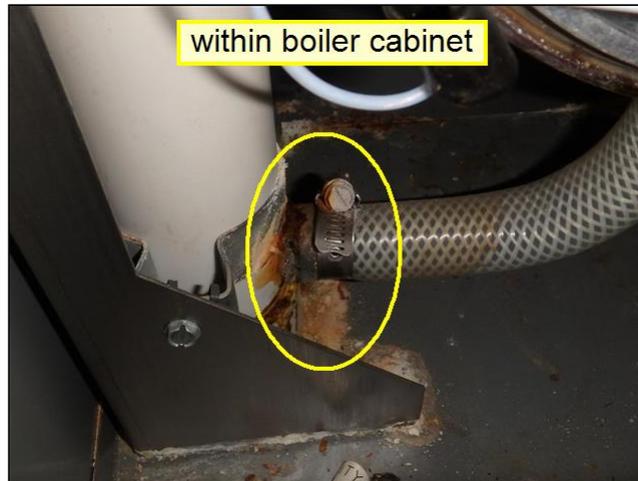
4.4 Item 1(Picture)

There is a leak at the condensate drain line that we recommend be serviced.

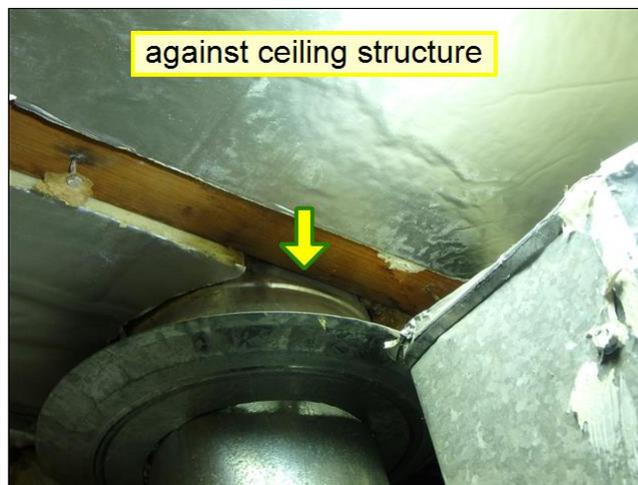
4.6 Item 1(Picture)

The double-walled heat vent for the furnace is too close to combustible material and needs to be 1 inch away for fire safety reasons and needs to be serviced.

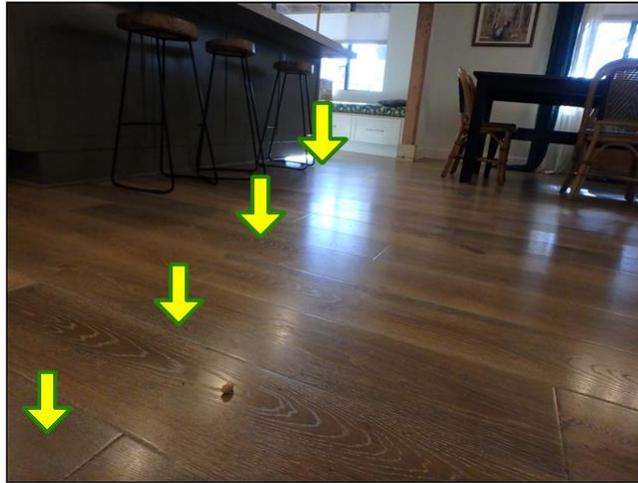
6.2 Item 1(Picture)

There is a slope in the laminate floor located in the kitchen/DR area of the residence. This is an indication of slab cracking. It is normal for all concrete slabs to crack and there is no indication of any structural problems from this visual observation. All of the areas adjacent to these cracks, walls and doors show no signs of movement. In general, since a Home Inspection is a visual inspection, inspection of the slab-on-grade foundation is limited by the fact that typically, most of the foundation and slab is hidden underground or by interior floor coverings. Where possible, we inspect that portion of the foundation visible at the home exterior between grade and the bottom of the exterior wall covering. Shrinkage cracks are often visible and are not a structural concern. It is possible for ants and/or moisture to enter the foundation through these cracks by capillary action and this moisture may cause damage typically detectable only through invasive techniques that lie beyond the scope of the General Home Inspection. Recommend removing the flooring and further evaluate the crack for signs of moisture intrusion, then seal/level the crack and install new floor if concerned.

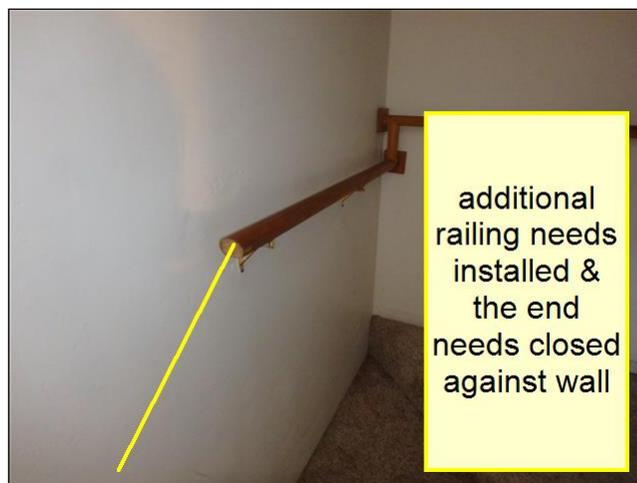
6.4 Item 1(Picture)

Stairways with walls on either side need handrails attached to one or both walls. There are several factors that determine the required configuration: the number of risers, the width of the stairs and the use of the building (commercial, residential, etc.). For single-family homes, a handrail is required on one side of a set of stairs. However, if the stairs consist of three risers or less, no handrail is required. What's more, the handrail should be 1-and-a-quarter inches to 2 inches in diameter, have at least a 1-and-one-half-inch space between the handrail and the adjacent wall and should not project out more than 3-and-one-half inches from the stair wall. There's more.

Although there are some exceptions, the handrail must be continuous for the full length of the stair run, and the ends must curve into the wall so as not to catch a sleeve. In addition, the handrail must be located at least 34 inches but

not more than 38 inches above the tread nosing. The tread is the surface that you walk on; the riser is the vertical panel between each tread.

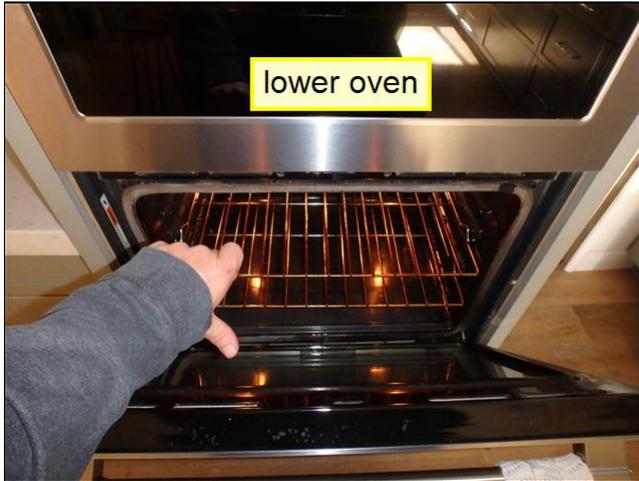
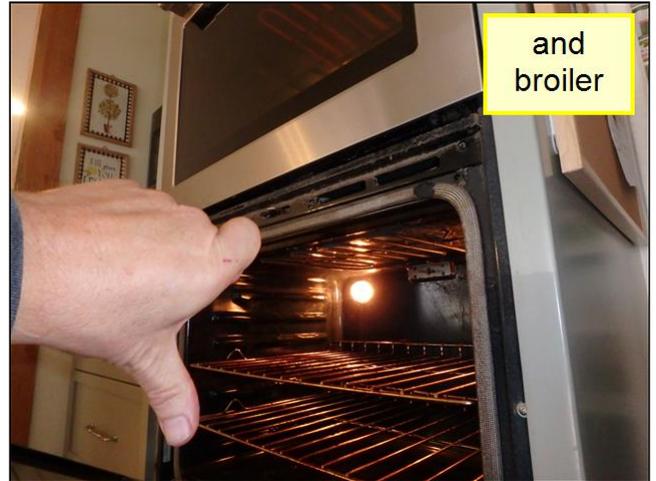
The oven/broiler did not respond to its switch and we recommend it be serviced by an appliance technician.

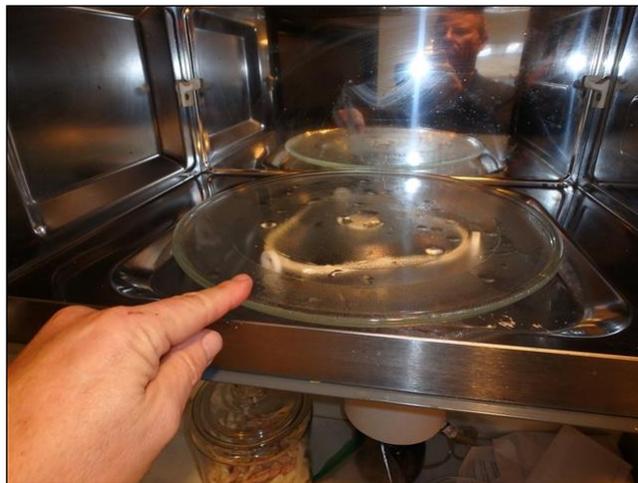
7.5 Item 1(Picture)

The microwave responded to its switch but the tray did not rotate and we recommend it be repaired/replaced.

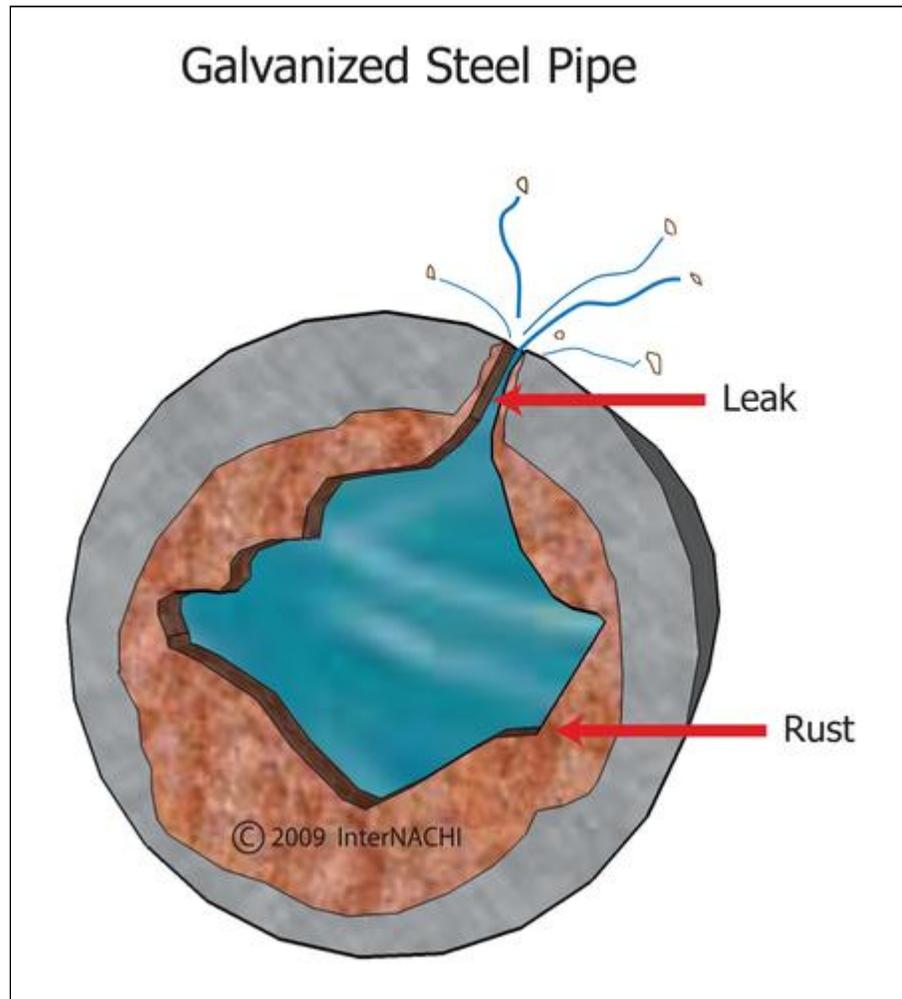
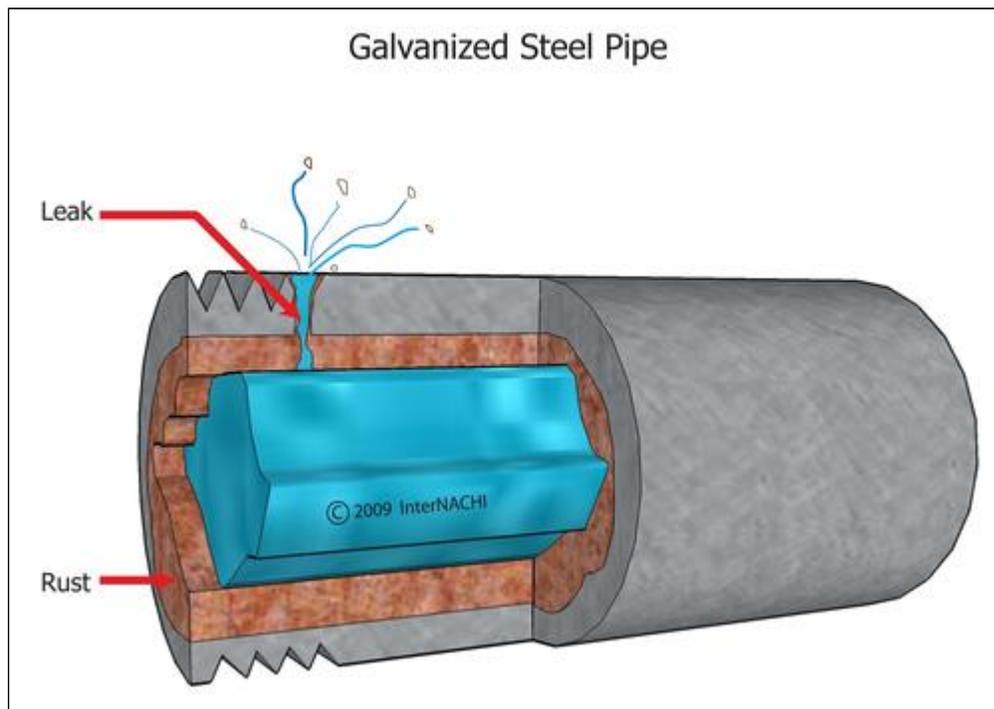
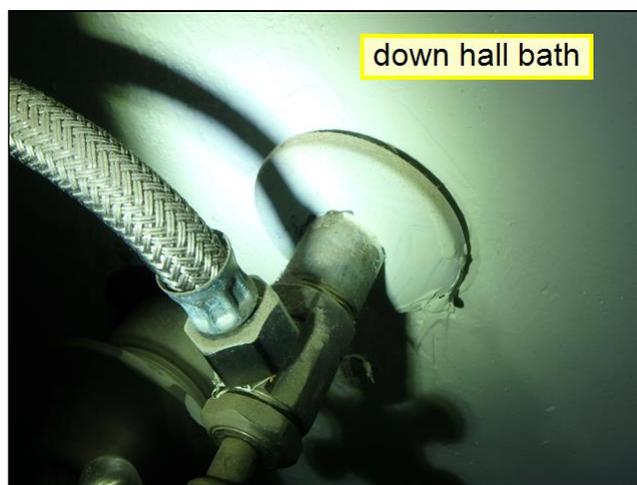
Some of the potable water pipes within this residence are galvanized, and are assumed to be original. They have a useful life of 40 to 50 years and deteriorate by internal corrosion which is not visible. If these pipes are plumbed through the attic leaks can cause considerable damage and be costly. Cold climates and non/poorly insulated plumbing in attics is a recipe for bursted pipes. They may produce rusty looking water from time to time, and because the water volume in such pipes will gradually be reduced by a build-up of minerals within them, we do not fully endorse them. Some of the galvanized piping has been replaced and you should expect to replace the remainder as time goes on and leaks develop. Recommend additional system performance evaluation by a plumber, who can also apprise you of the cost of a copper/PEX re-pipe.

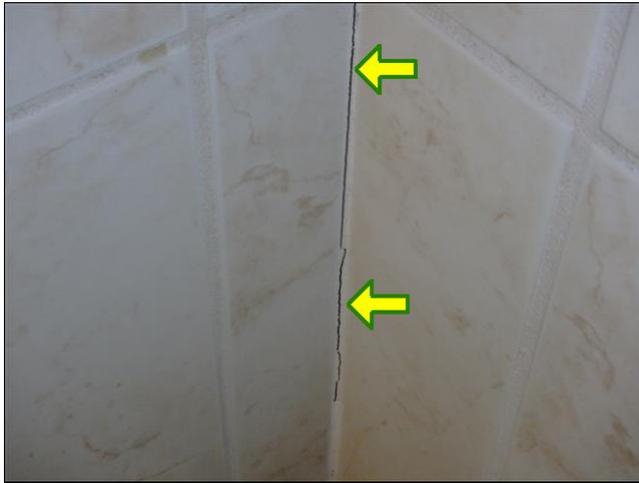
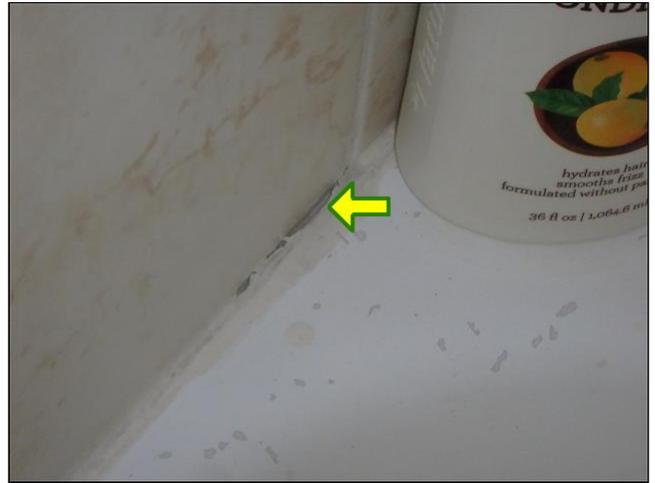
The shower stall grout lines are in need of fresh grout or caulk in places. Cracks in the grout line can allow moisture to penetrate the shower enclosure and reach the backer board and framing members behind the tile. This condition can cause damage over time. Recommend sealing the cracks with an appropriate sealant material.

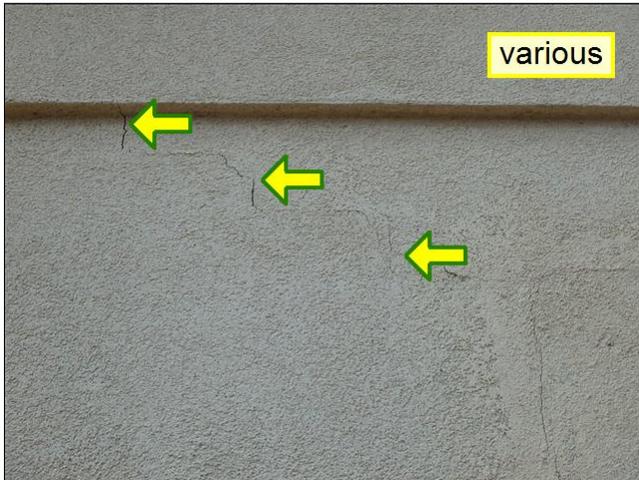
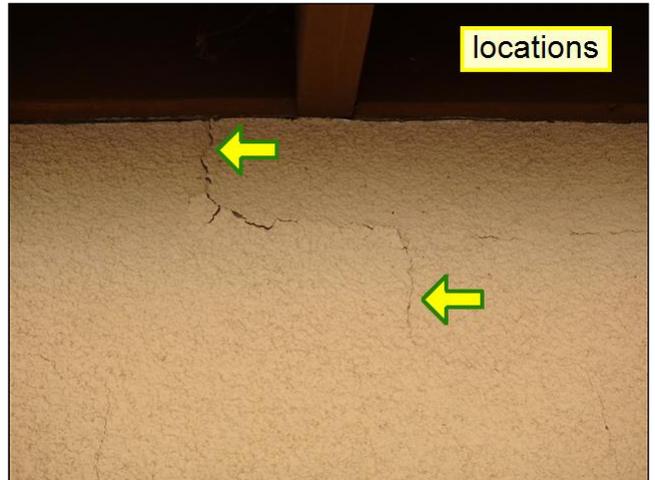
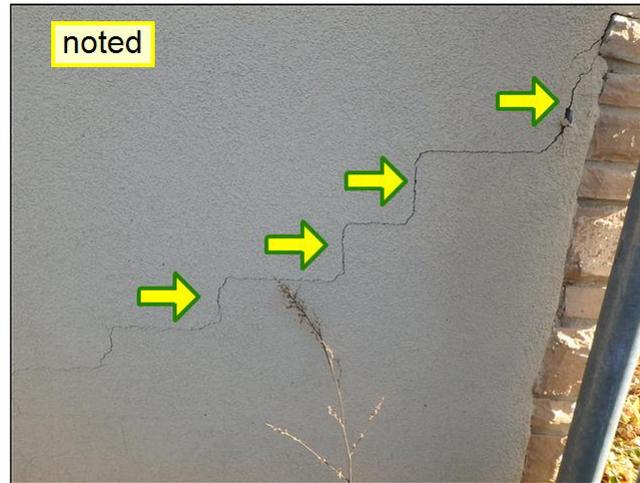
There are cracks in the masonry blocks/bricks indicating movement that we recommend be sealed and monitored. Wood frame walls tend to absorb the effects of movement, whereas masonry walls will crack and reflect the slightest movement. Cracks such as these are common, especially on older homes and suggest slight settling of the soil. You may wish to consult with a grading and drainage contractor or structural engineer regarding this, but we feel, refraining from (over)irrigation, correcting the faulty grading, sealing cracks in the surrounding hard surfaces, and the addition of full gutters and downspouts with extensions would all be helpful and recommended to direct moisture away from the foundation and slow the settling process.

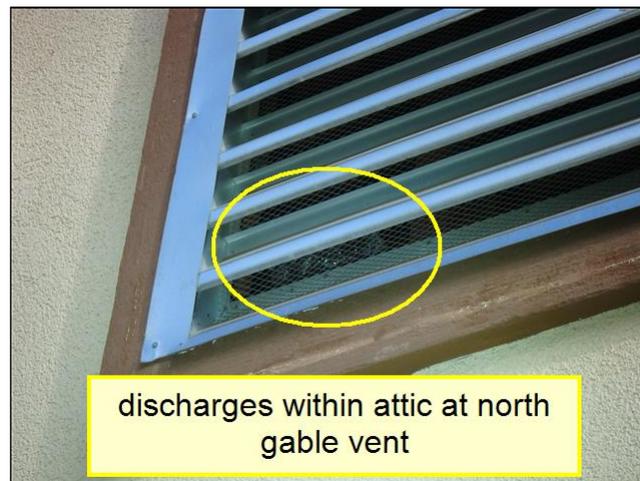
15.5 Item 1(Picture)

The clothes dryer vent discharges into the attic. The moisture from exhausting dryer air causes elevated relative humidity in the unheated attic. Elevated relative humidity in this area can promote mold growth and increase the moisture content in the wood framing to a level that promotes fungal growth and rotting. A sustained relative humidity, which is higher than 60 percent (60%), is one of the essential elements for creating an environment that promotes mold growth. High levels of humidity in the attic space can raise the moisture content of the wood framing. A sustained moisture content of 20 percent or higher in wood can promote fungal growth that can grow deep into the wood surfaces and produce wood decay. Recommend replacing the existing vent with a continuous metal vent pipe that leads to an exterior wall, or through the roof and exhausts outside of the attic space with an appropriate cover. More info [here](#).

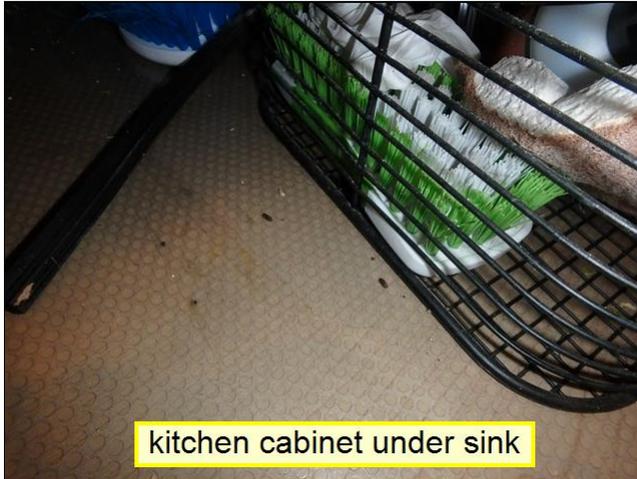
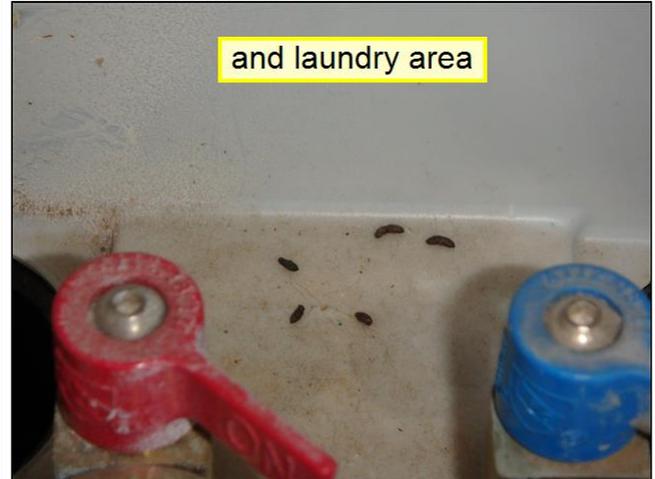
There is evidence of rodent activity within the living space of the residence, and we will attempt to identify the point(s) of entry, but repeated sealing and diligent maintenance is required to prevent intrusion, especially if the home is in a rural setting.
