Thoreau Home Inspection

CONFIDENTIAL INSPECTION REPORT

777 Bliss St, Anywhere, Arizona

6/4/2015 9:00 am to 12:00 pm

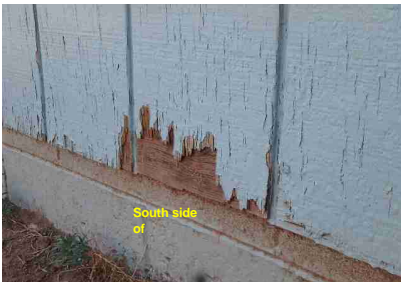
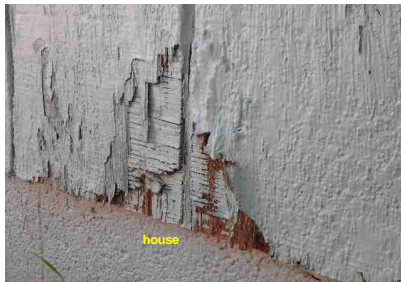
1.6 - Portions of the wood siding are swelling and delaminating as a result of moisture damage and we recommend it be replaced.

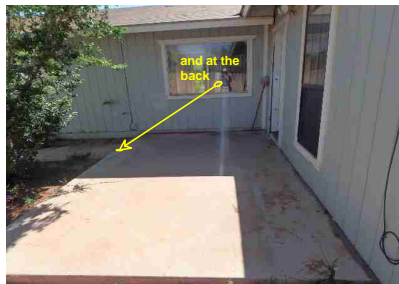
1.9 - There are offsets in the walkways that could prove to be trip-hazards that we recommend be marked and monitored for safety.

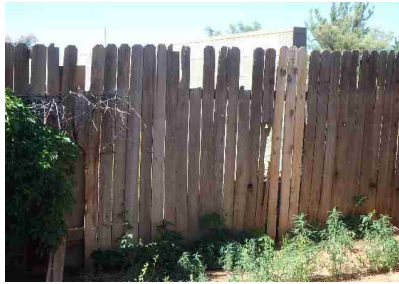
1.10 - Sections of the fence have loose, missing or broken boards that we recommend be repaired

Sections of the fence have loose missing or broken boards that we recommend be repaired - *Continued*

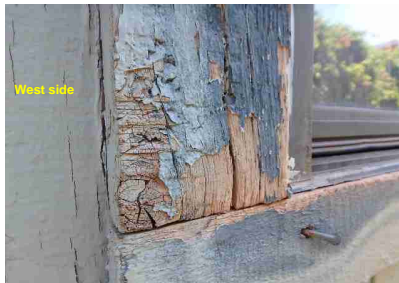
1.11 - There are sections of the fascia and trim that are loose and deteriorated we recommend they be replaced.

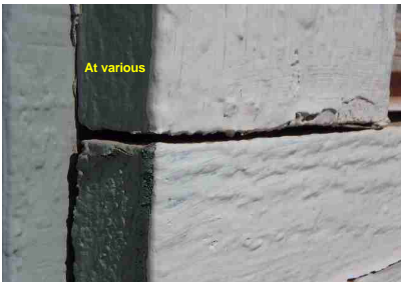
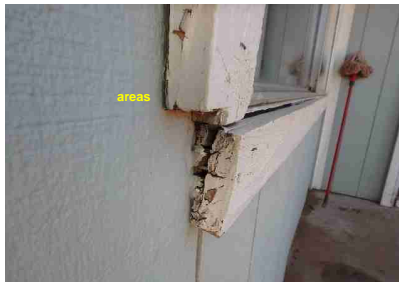
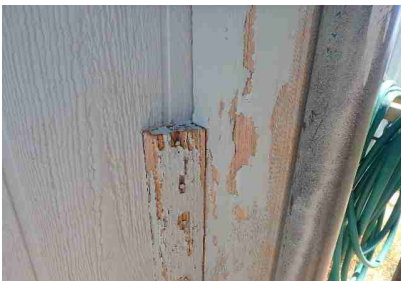
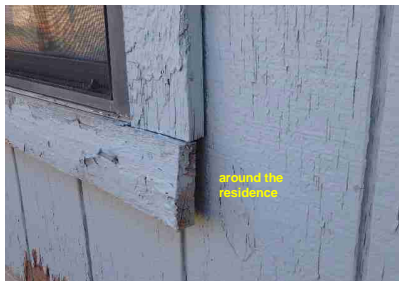
1.12 - The fascia and trim need typical maintenance service such as securing, scraping, sanding, sealing and painting to prevent moisture damage.

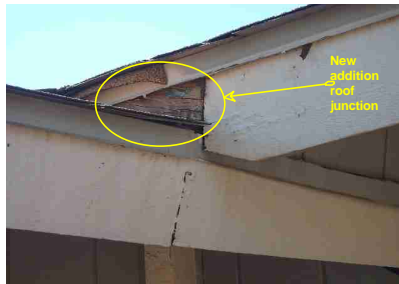
1.13 - Portions of the trim have peeling paint and we recommend it be serviced to prevent deterioration from the sun and moisture.

Portions of the trim have peeling paint and we recommend it be serviced to prevent deterioration from the sun and moisture.

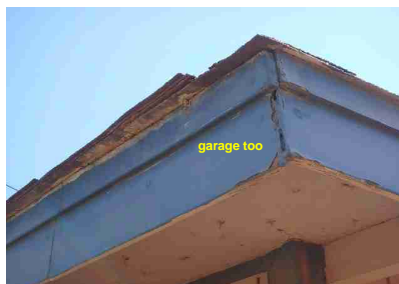
1.14 - The fascia boards are separating at the corners and we recommend these areas be sealed to prevent moisture damage.

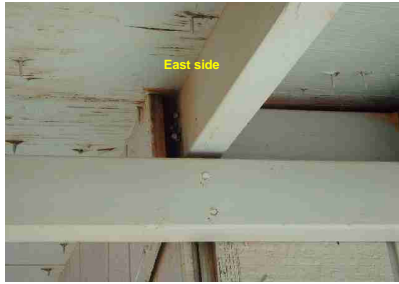
1.16 - Sections of the eaves are open to attic space and we recommend these areas be sealed to prevent pest intrusion.

Sections of the eaves are open to attic space and we recommend these areas be sealed to prevent pest intrusion - *Contir.*

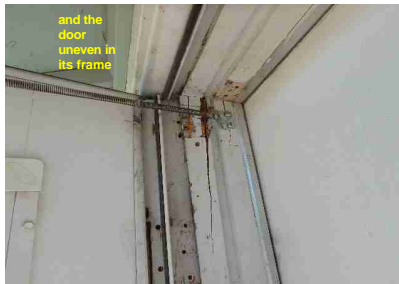
1.18 - The entry doors need maintenance or replacement service of the door trim, hardware and weather stripping.

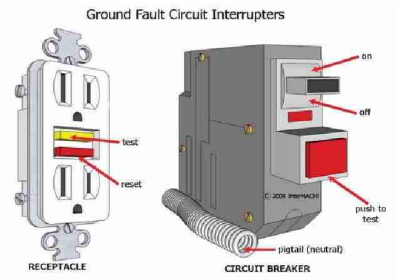
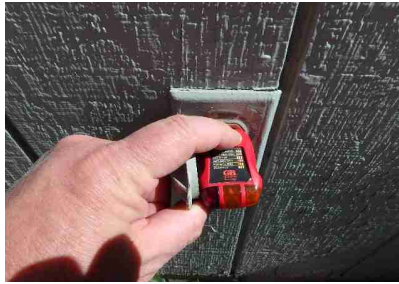
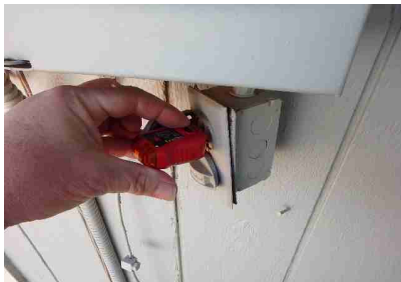
1.20 - We recommend that all of the exterior outlets be upgraded to have ground fault protection.

We recommend that all of the exterior outlets be upgraded to have ground-fault protection - *Continued*

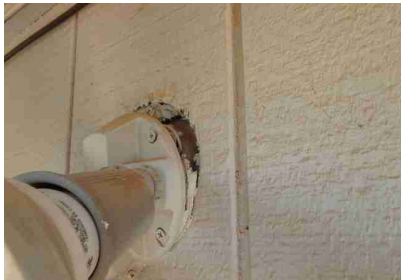
1.21 - A light fixture is loose at the rear door and we recommend that it be secured.

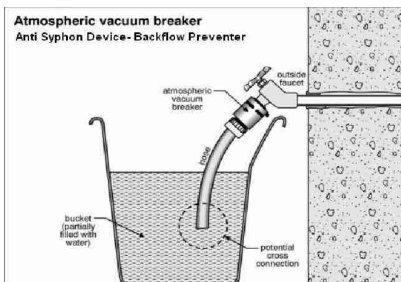
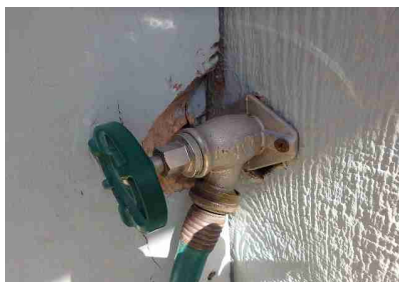
1.22 - The hose bibs that we tested are functional, but do not include anti-siphon valves and we recommend having these installed. These valves are relatively inexpensive and add a level of safety to prevent contaminated water from entering the potable system.

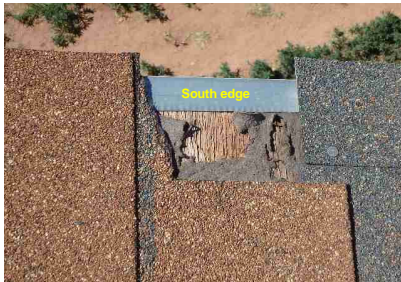
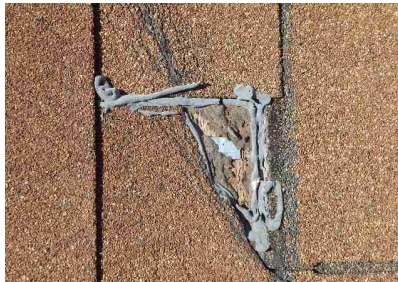
3.3 - Portions of the roof have exposed sheathing and we recommend immediate repairs.

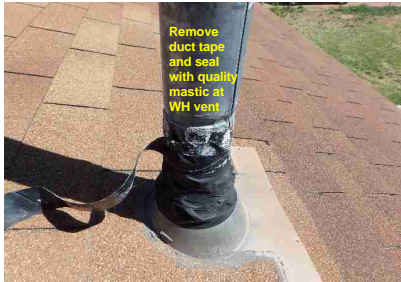
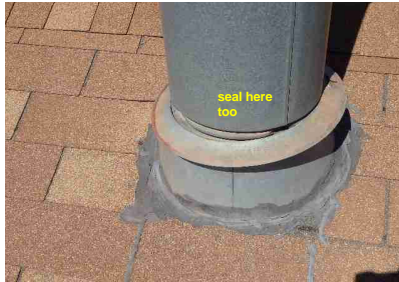
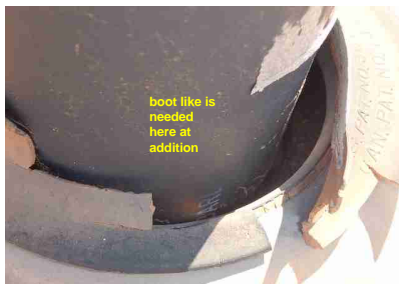
3.6 - We recommend the roof flashings be sealed and regularly maintained. They are comprised of metal that seals valleys and vents and other roof penetrations, and are the most common point of leaks.

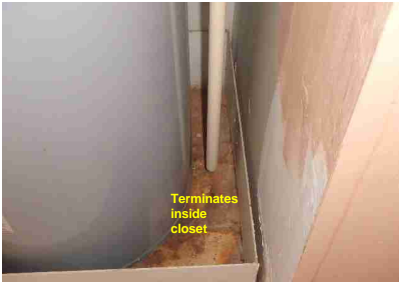
5.2 - The discharge pipe from the pressure relief valve needs to be plumbed to the exterior and terminate no more than twenty-four inches above grade and closer than six inches to it.

The discharge pipe from the relief valve needs to be plumbed to the exterior - *Continued*

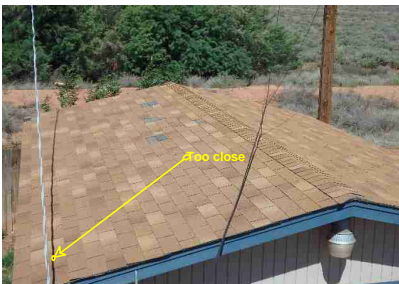
6.1 - The overhead conductor lines pass too low over the ridge of the pitched roof. Common safety standards require them to be at least three feet above the ridge, and we advise you consult an electrician about this.

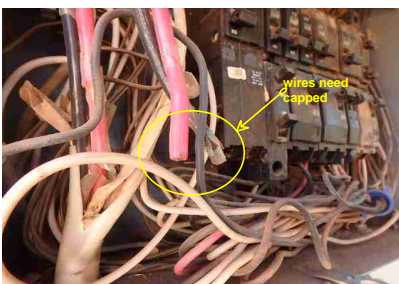
6.2 - There are exposed wires that we recommend be capped.

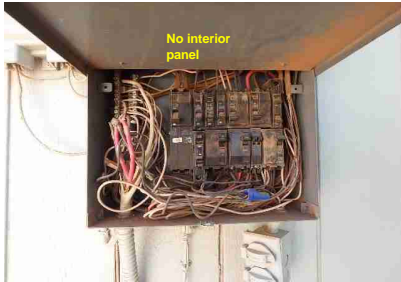
6.4 - The interior panel cover is missing, and we recommend it be replaced.

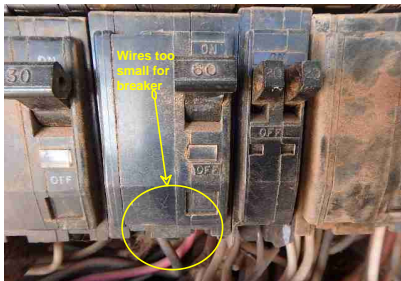
6.6 - A sixty-amp breaker is serving undersized wires, which is a fire-hazard that we recommend be corrected by an electrician.

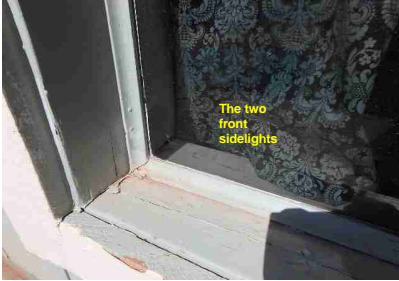
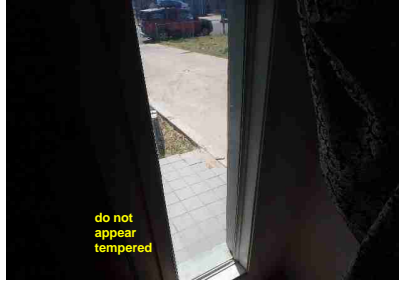
9.2 - The large windows on either side of the front entry door do not appear to be tempered and we recommend they be replaced or at least closely monitored especially if young children or the elderly occupy or visit the residence.

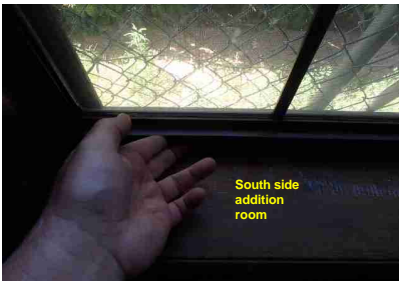
9.3 - A window return spring is out of its track and we recommend it be repaired.

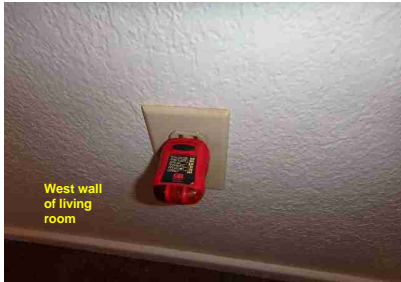
9.5 - An outlet has no power and we recommend it be serviced.

An outlet has no power and we recommend it be serviced - *Continued*

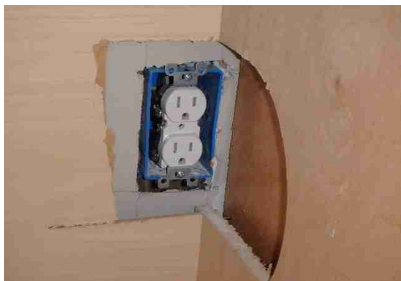
10.3 - An outlet under the sink is missing a cover plate and we recommend it be serviced.

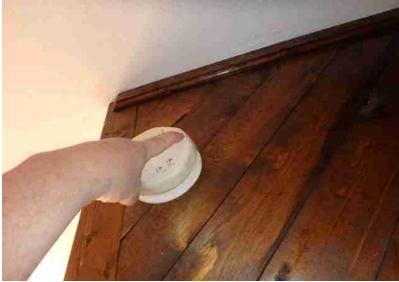
11.1 - The smoke detector did not respond, and we recommend it be serviced.

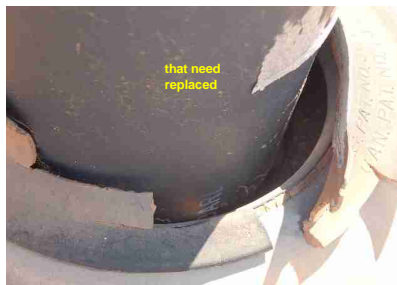
13.1 - Moisture has entered the attic space from defective plumbing vent boots and we recommend they be replaced.

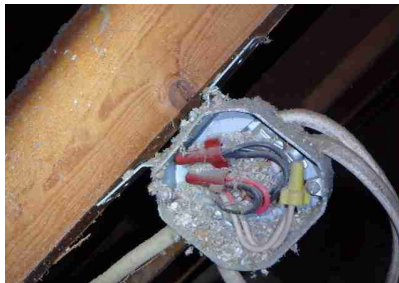
13.3 - There are open electrical junction boxes, which we recommend be sealed to contain any arcing or sparking that might occur.

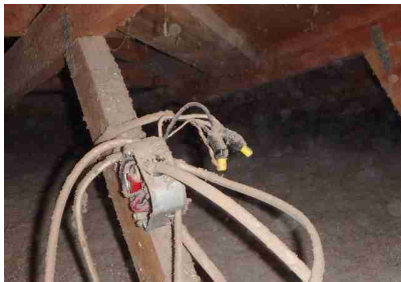
13.4 - An electrical connection has been incorrectly made outside of a junction box, which is a potential fire-hazard. We advise all such connections be made inside a junction box, in order to contain any arcing or sparking within the box.

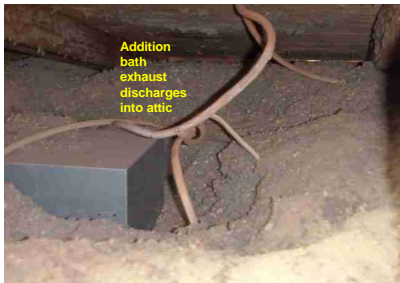
13.6 - We recommend the bathroom exhaust duct be extended to an exterior vent port to assist the removal of moist air to the outside of the home.

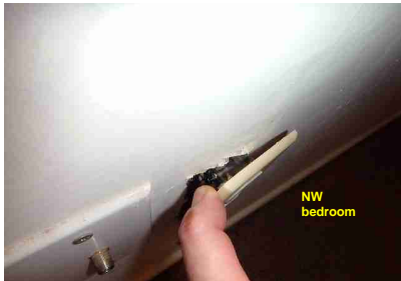
14.4 - An outlet is loose and needs to be re-secured to the wall.

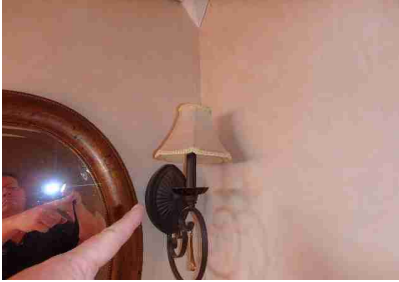
15.6 - The wall light does not respond, and we recommend it be serviced.

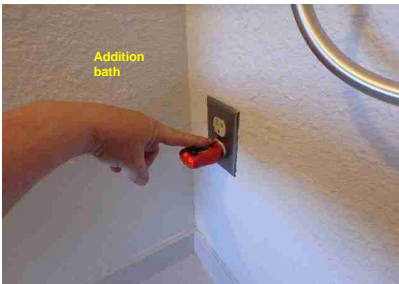
Outlets

15.7 - We recommend the outlets be upgraded to have ground-fault protection.

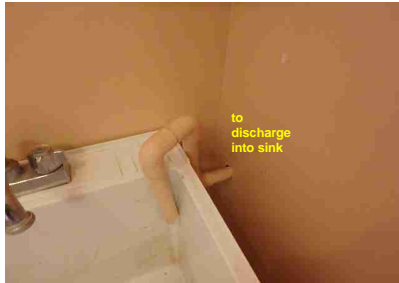
16.3 - The drain pipe from the washer is plumbed to the sink and needs to be further evaluated with correction as necessary by a plumbing specialist.

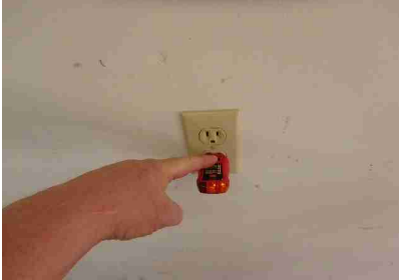
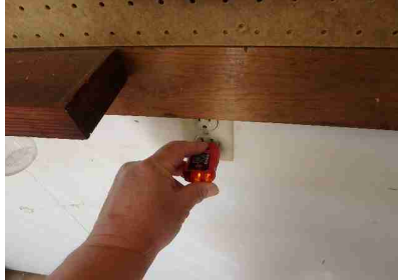
17.3 - We recommend the outlets be upgraded to have ground fault protection, which is mandated by current standards and is an important safety feature.

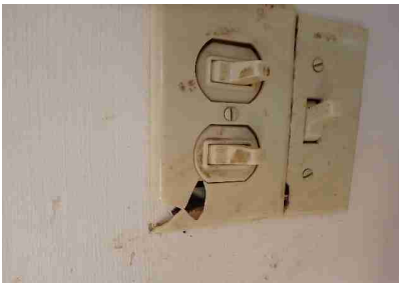
17.4 - An switch has a loose or broken cover and we recommend it be serviced.

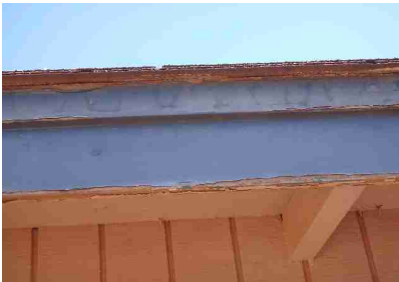
Roof

17.5 - The roof is missing its drip edge flashing and we recommend it be replaced.
