# Thoreau Home Inspection

## CONFIDENTIAL INSPECTION REPORT

777 Bliss St, Anywhere, Arizona

6/4/2015 9:00 am to 12:00 pm

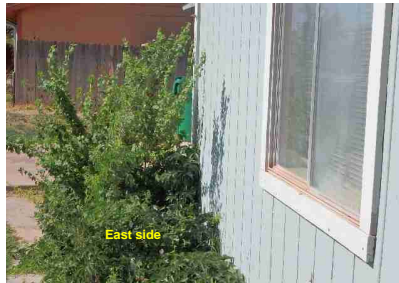
1.3 - Vegetation is encroaching on the structure, and should be kept a minimum of twelve inches away for the general welfare of the walls and foundation.

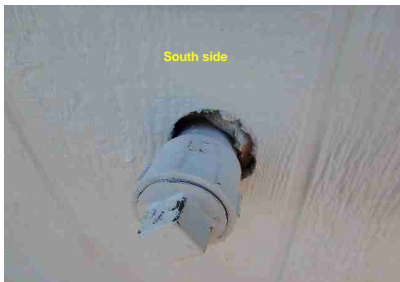
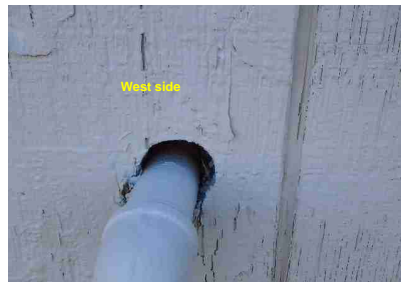
1.13 - There are holes in the siding that we recommend be sealed to prevent pest intrusion.

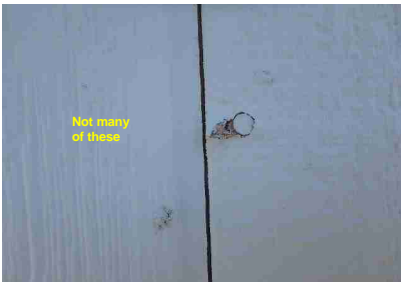
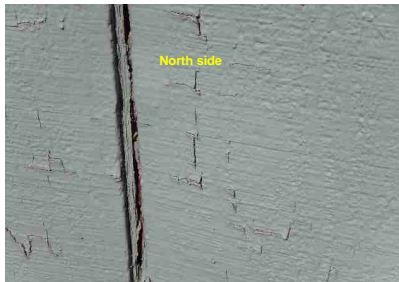
1.15 - There are separations or nail-pops on the siding that we recommend to be sealed to prevent moisture damage.

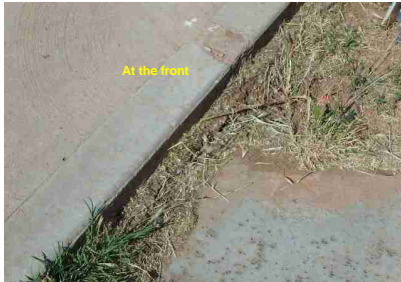
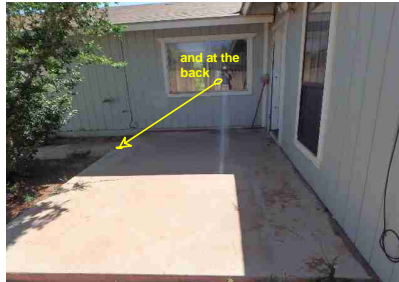
1.20 - There are offsets in the walkways that could prove to be trip-hazards that we recommend be marked and monitored for safety.

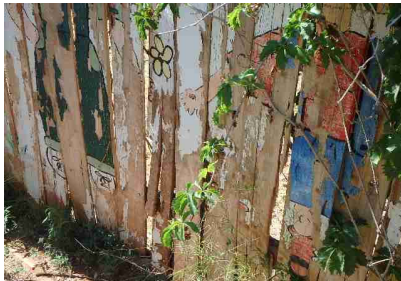
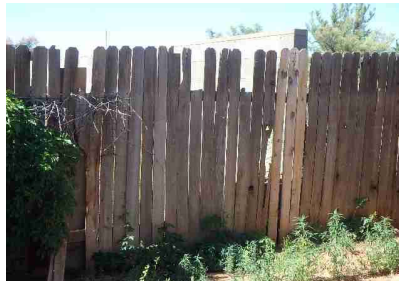
1.21 - Sections of the fence have loose, missing or broken boards that we recommend be repaired

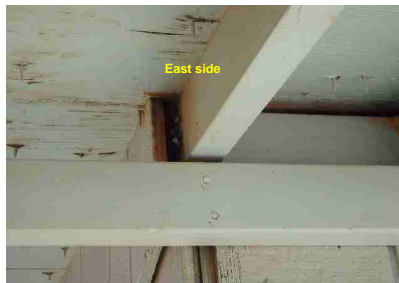
1.27 - Sections of the eaves are open to attic space and we recommend these areas be sealed to prevent pest intrusion.

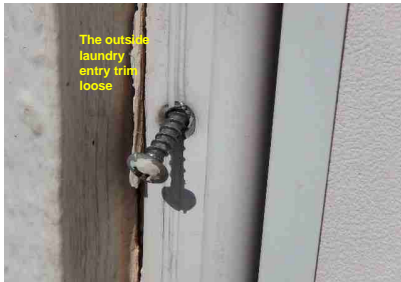
1.29 - The entry doors need maintenance or replacement service of the door trim, hardware and weather stripping.

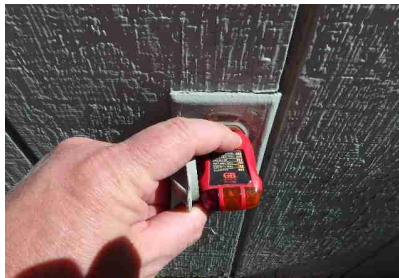
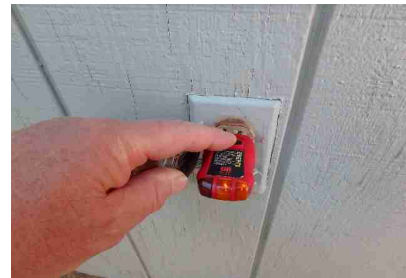
1.34 - We recommend that all of the exterior outlets be upgraded to have ground fault protection.

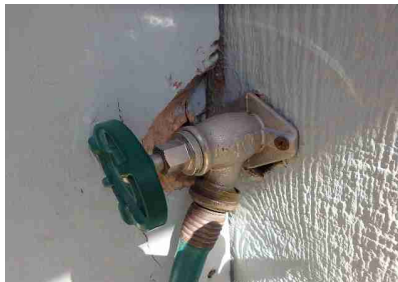
1.37 - The hose bibs that we tested are functional, but do not include anti-siphon valves and we recommend having these installed. These valves are relatively inexpensive and add a level of safety to prevent contaminated water from entering the potable system.

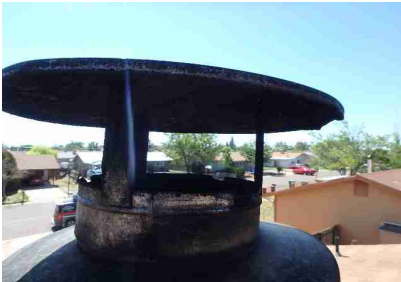
4.2 - The chimney does not have a spark arrestor, which is mandated in most jurisdictions and we recommend one be installed.

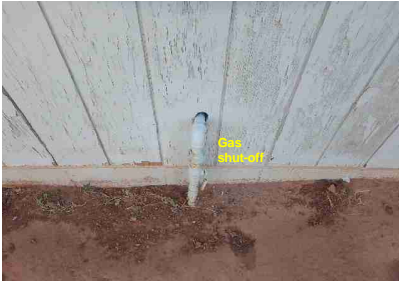
5.9 - The gas main shut-off is located at the rear of the residence. You should be aware that gas leaks are not uncommon, particularly underground ones, and that they can be difficult to detect without the use of sophisticated instruments, which is why natural gas is odorized in the manufacturing process. Therefore, we recommend that you request a recent gas bill from the sellers, so that you can establish a norm and thereby be alerted to any potential leak.

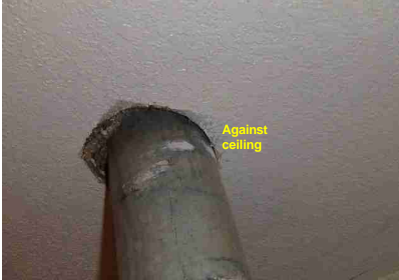
5.17 - The vent pipe is too close to combustible material and we recommend that it be serviced. A single-walled vent pipe should be six inches away from any combustible material, and a double-walled vent pipe should be one inch away.

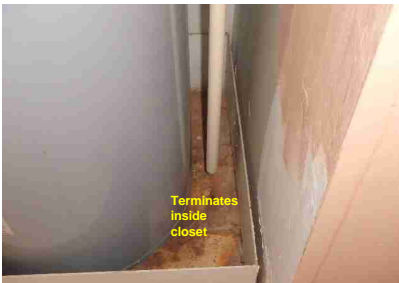
5.18 - The discharge pipe from the pressure relief valve needs to be plumbed to the exterior and terminate no more than twenty-four inches above grade and closer than six inches to it.

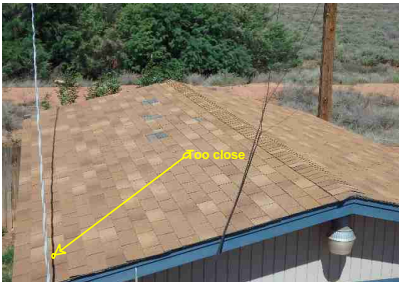
6.3 - The overhead conductor lines pass too low over the ridge of the pitched roof. Common safety standards require them to be at least three feet above the ridge, and we advise you consult an electrician about this.

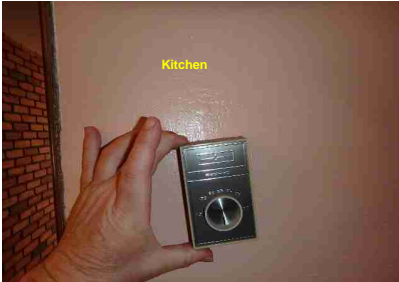
7.8 - A thermostat is loose and we recommend it be secured to the wall.

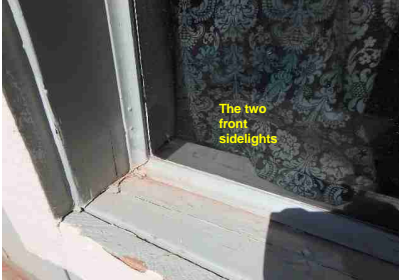
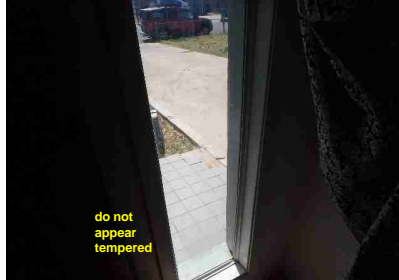
9.5 - The large windows on either side of the front entry door do not appear to be tempered and we recommend they be replaced or at least closely monitored especially if young children or the elderly occupy or visit the residence.

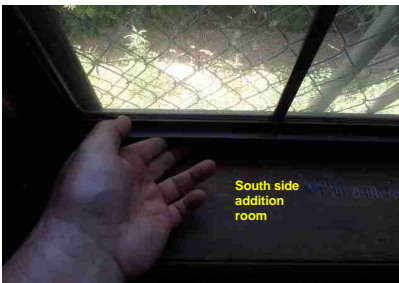
9.6 - A window return spring is out of its track and we recommend it be repaired.

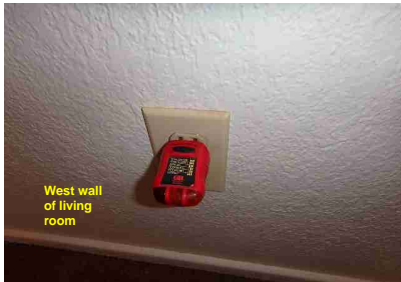
9.11 - An outlet has no power and we recommend it be serviced.

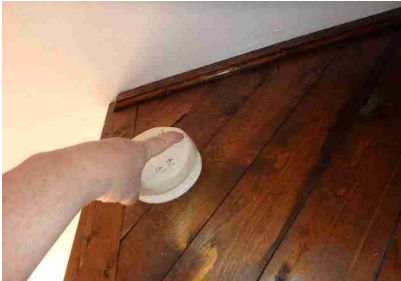
11.2 - The smoke detector did not respond, and we recommend it be serviced.

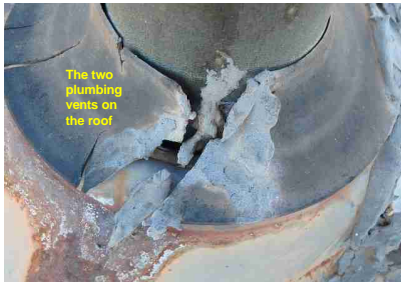
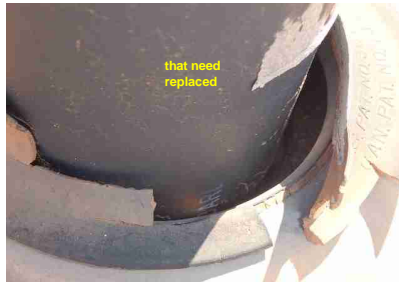
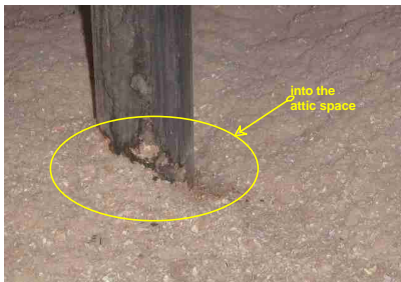
13.4 - Moisture has entered the attic space from defective plumbing vent boots and we recommend they be replaced.

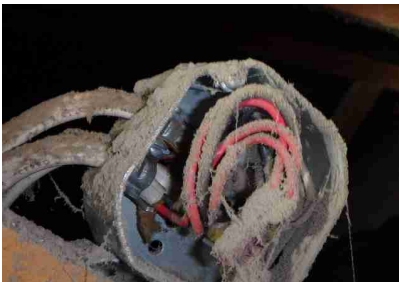
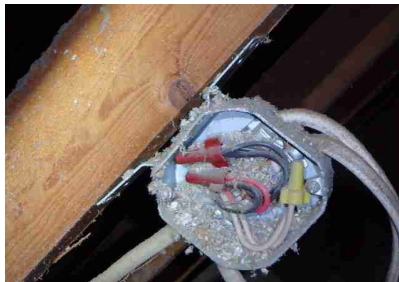
13.6 - There are open electrical junction boxes, which we recommend be sealed to contain any arcing or sparking that might occur.

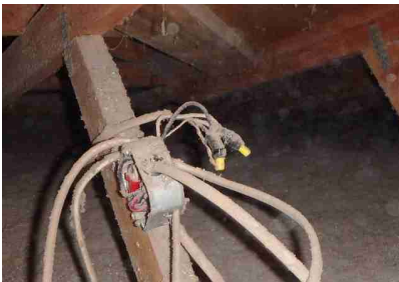
13.7 - An electrical connection has been incorrectly made outside of a junction box, which is a potential fire-hazard. We advise all such connections be made inside a junction box, in order to contain any arcing or sparking within the box.

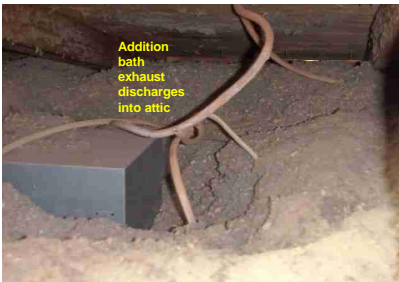
13.10 - We recommend the bathroom exhaust duct be extended to an exterior vent port to assist the removal of moist air to the outside of the home.

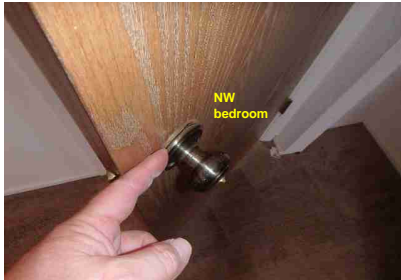
14.2 - A door knob is loose and we recommend it be serviced.

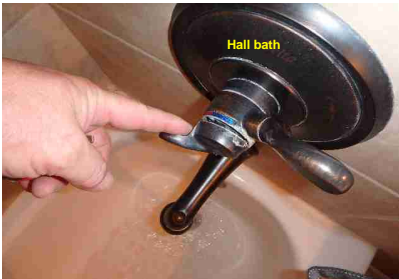
15.9 - The tub/shower valves are loose or missing components, and we recommend they be serviced.

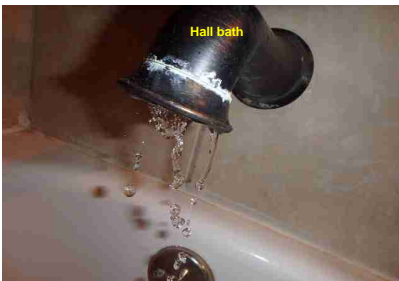
15.10 - The shower diverter valve in the tub/shower is defective, and we recommend it be serviced.

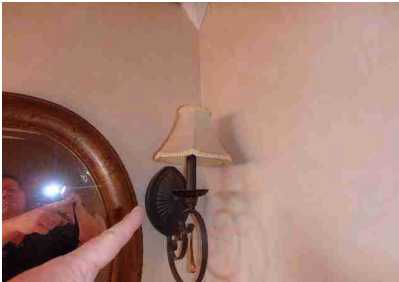
15.16 - The wall light does not respond, and we recommend it be serviced.

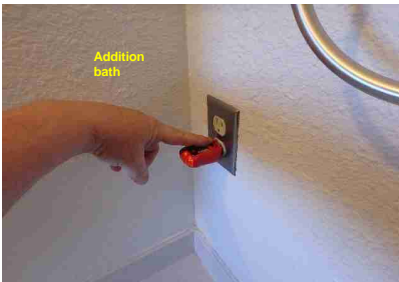
15.17 - We recommend the outlets be upgraded to have ground-fault protection.

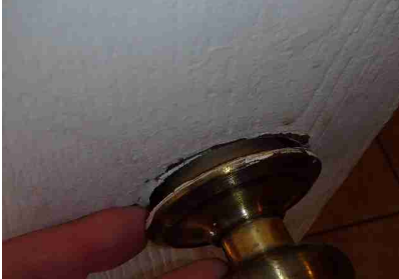
16.1 - The door knob needs to be serviced to work smoothly.

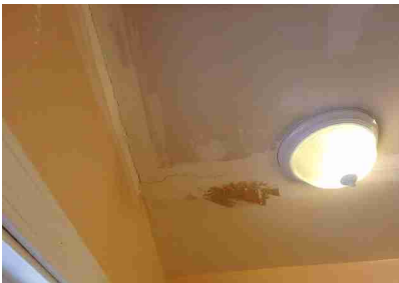
16.3 - There is a repair on the ceiling, which we advise you ask the sellers to explain or have explored further.

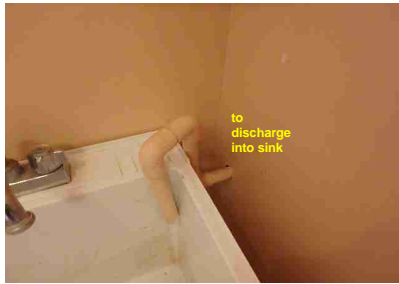
16.8 - The drain pipe from the washer is plumbed to the sink and needs to be further evaluated with correction as necessary by a plumbing specialist.

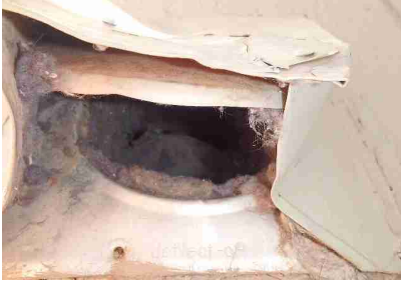
16.13 - The dryer vent cover is bent or crushed restricting its flow and we recommend it be serviced.

The dryer vent cover is bent or crushed restricting its flow and we recommend it be serviced - *Continued*

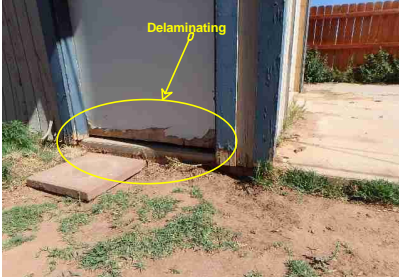
17.4 - The base of the garage side door is moisture damaged and delaminating, and we recommend it be repaired.

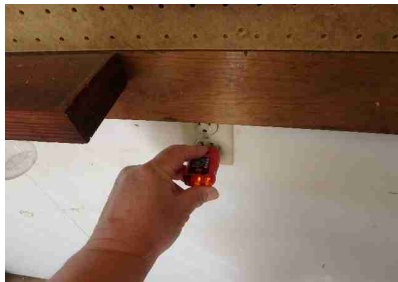
17.7 - We recommend the outlets be upgraded to have ground fault protection, which is mandated by current standards and is an important safety feature.

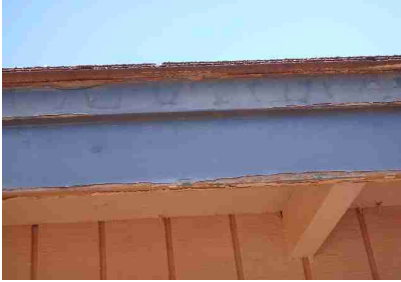
17.9 - The roof is missing its drip edge flashing and we recommend it be replaced.

The roof is missing its drip edge flashing and we recommend it be replaced - *Continued*
